PROCEEDINGS OF NATIONAL CONFERENCE ON **ROAD PAVEMENT FAILURE IN NIGERIA**

**CHALLENGES OF ROAD
PAVEMENT FAILURE IN NIGERIA**

HELD AT NICON LUXURY HOTEL, ABUJA, NIGERIA
7TH – 9TH MAY 2013

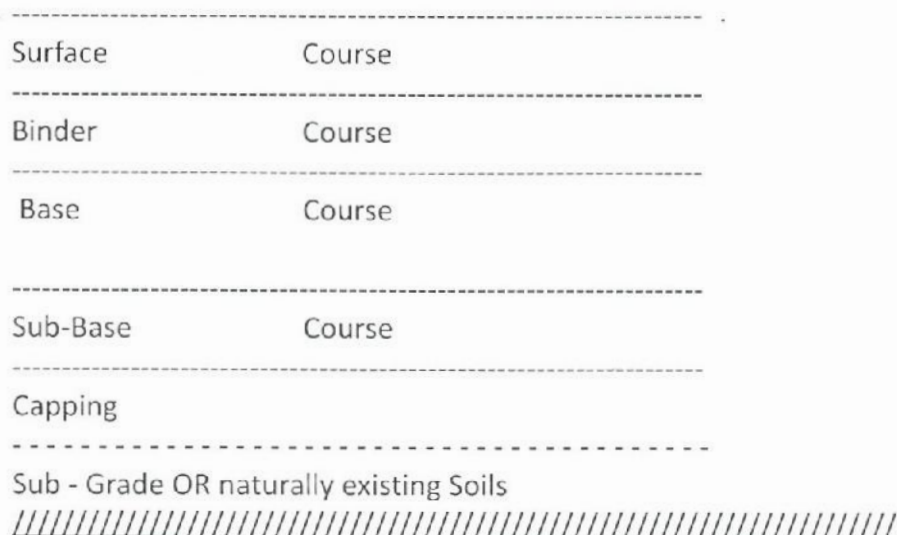
Figure 2: Flexible Road Structure typical cross-section

When a road is built, the surface of the ground must be excavated after general clearing to remove all organic soils as well as topsoil to the designed depth of the intended road. Organic soils and Topsoil do not support loading and even though they may appear strong in the dry OR semi-dry (partially saturated) conditions, they will actually collapse in contact with moisture leading to failure and even washouts of road pavement. On the removal/scraping of the undesirable top layers of the soil to the designed depths, preparation is carried out on the exposed ground through a combined action of charging with soil, mixing, and compaction using appropriate construction plants such as scrapers, dumpers, excavators, dozers, caterpillars, roller compactors, etc. The road pavement itself will then be built up above the prepared surfaces and it usually consists of four (4) layers placed in the order shown in the sketch in figure 2, on the next page, which is standard all over the world.

Because the stress transmitted through the road structure from the Vehicles spreads and dissipates with depth, the stress concentration is only majorly pronounced in the upper layers and so stronger and more expensive materials are needed in the upper levels. Additionally, the nearer the surface, the flatter the profile must be to provide the ultimate geometry of the road cross-section. This is obviously because an uneven surface will be uncomfortable for vehicle occupants and will wear more quickly (each time a vehicle hits a bump, it is in effect hammering the surface). These factors are the main reasons for the layered construction of the road.

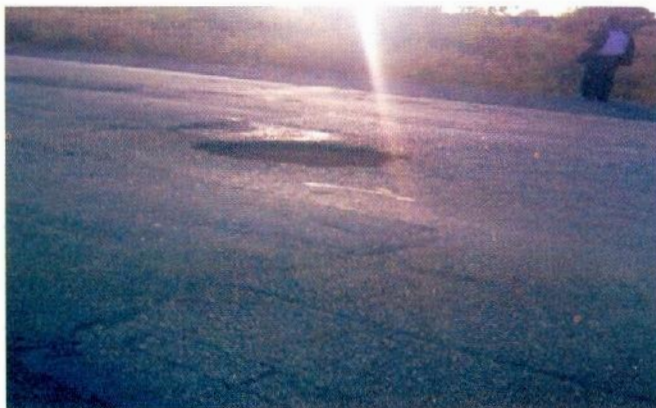
Figure 4: Linear longitudinal cracks

e) Linear longitudinal cracks can be a paving joint phenomenon most commonly found on all classes of roads. It is caused by the inability to fully compact the unconfined edge of a paving pass. The resulting low-density mix has insufficient strength to prevent cracking and will allow the asphalt to prematurely oxidize, harden, and eventually ravel. Another longitudinal crack frequently occurs between the wheel paths when segregation will occur where the two paver slat conveyors drop the HMA in front of the paver augers. Longitudinal cracks in the wheel path are usually load related and can lead to alligator cracking. In temperate regions, frost heaves in the base or subgrade can also cause longitudinal cracks.

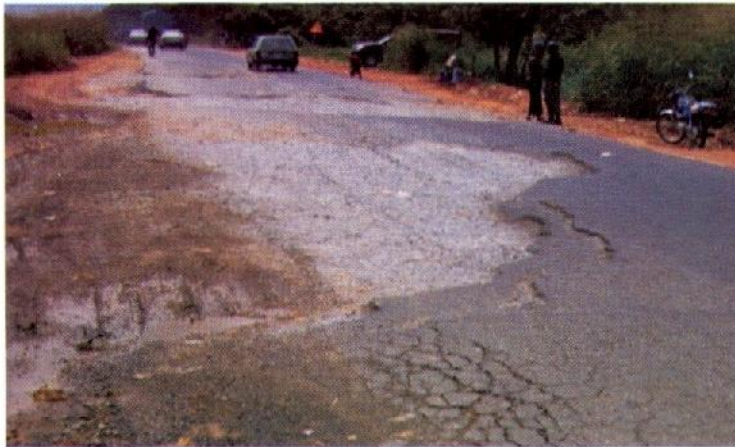
Figure 5: Edge Cracking

f) Edge cracks are longitudinal away from the pavement edge with or without transverse cracks branching out to the shoulder. Lack of lateral or shoulder support is the most common cause while settlement of the base soils, poor drainage and frost heaves (in temperate climate) are other causes.

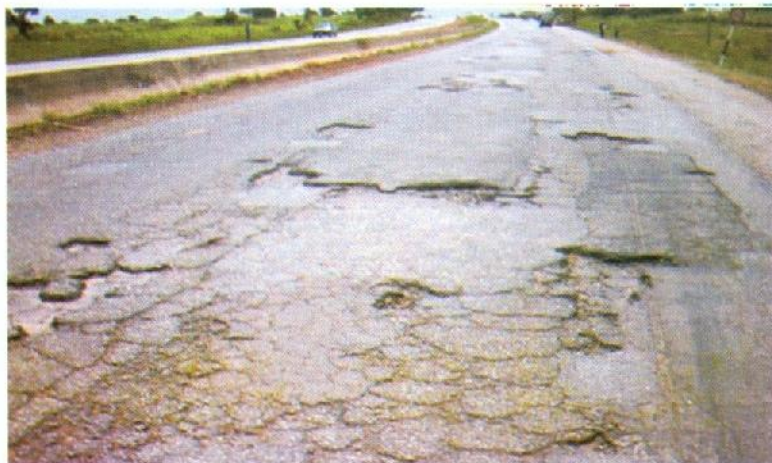
Figure 6: Slippage cracks

g) Slippage cracks are crescent shaped cracks resulting from traffic-induced horizontal forces caused by a lack of bond between the surface layer and the course below. This lack of bond may be due to dusts, dirt, oil, or the absence of a tack coat prior to placing the surface course.

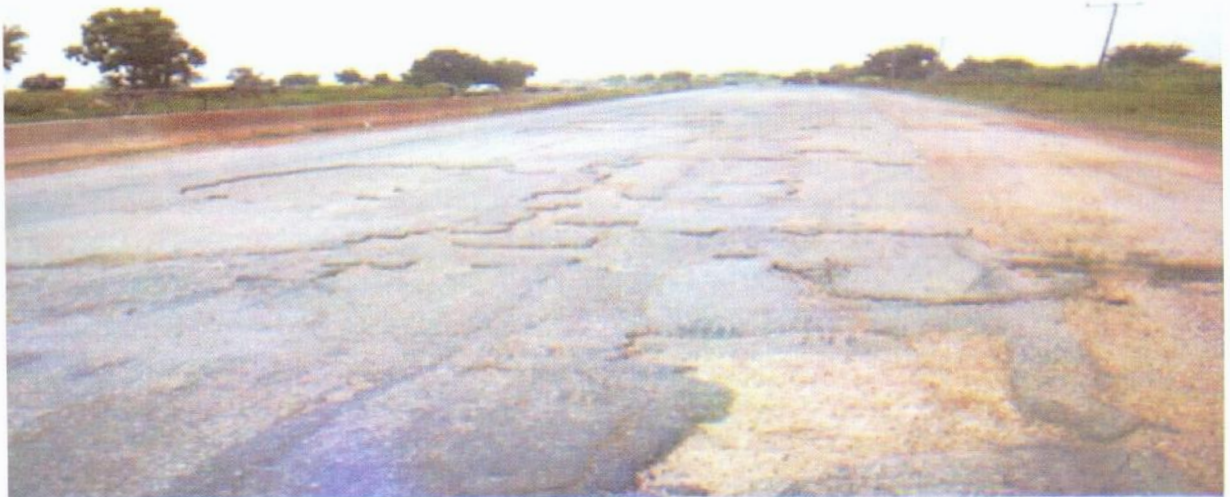
Figure 7: Delamination

b) Delamination is the localized loss of the entire thickness of the overlay caused by the lack of bond between the overlay and the original pavement. Water is also the chief culprit when it gets between the two layers of pavement. Delamination is usually confined to the wheel-path area and takes several years after the overlay to become a serious problem but once it occurs, is very difficult to properly patch. Cleaning the old surface and applying a light asphalt emulsion tack coat will go a long way toward alleviating this problem. A tack coat is especially helpful when the overlay thickness is less or equal to 50mm.

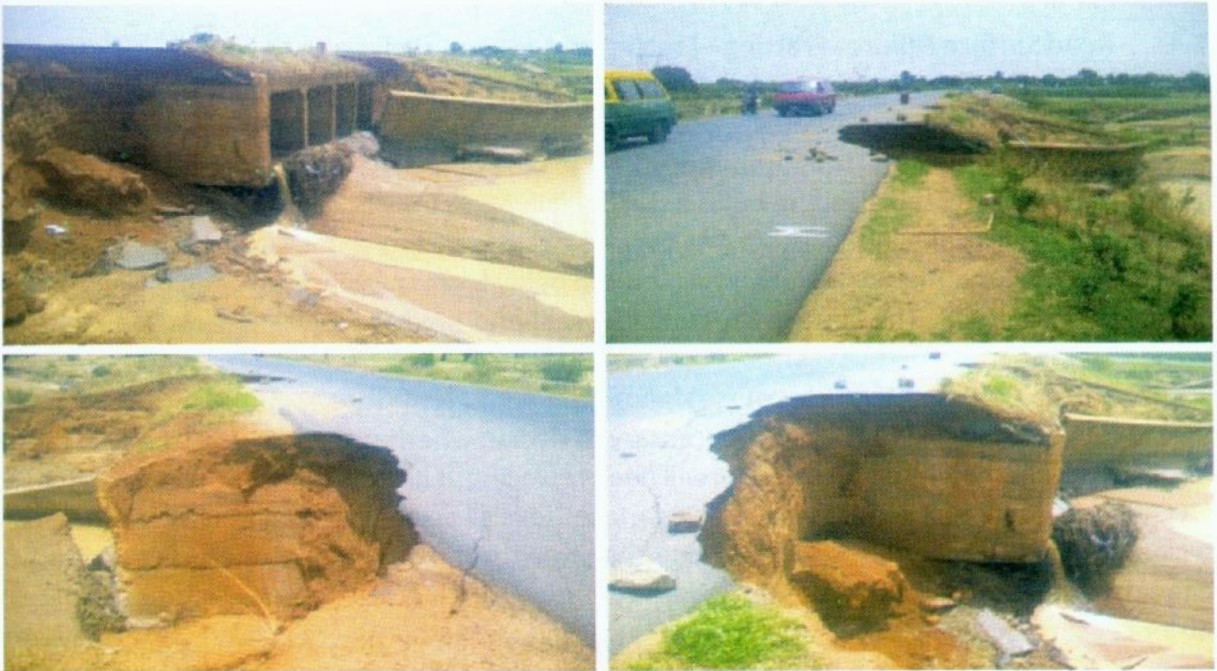
Figure 10: Failed Roadways due to Erosion and Poor Drainage

In all circumstances of failures, unless due to normal tear and wear, the theoretical position is that reconstruction or rehabilitation should normally be at the end of life-span of the roadway. Of course, routine maintenance should be undertaken of the surface layers and some roadway feature elements, but this should be a planned event and not extensive. Therefore, the presumption always is that the workmanship employed for laying/using the various construction materials was standard.

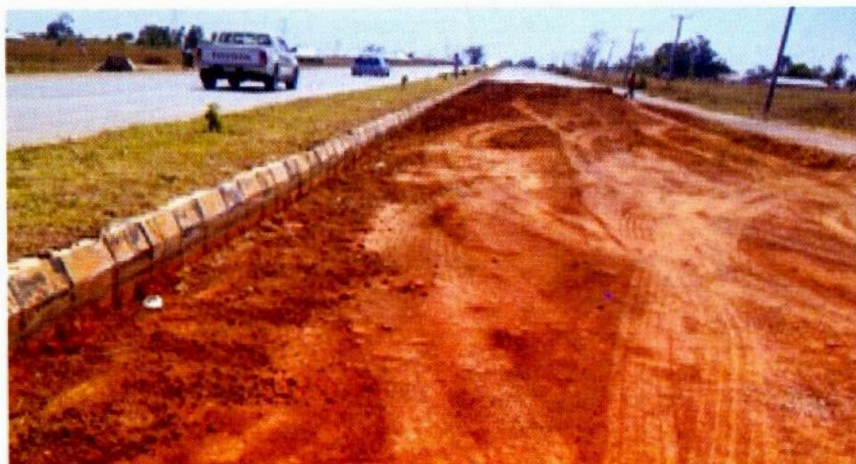
Figure 11: Pavement Failure during Construction

Having built good roads, it is important to protect these roads through routine and emergency maintenance and interventions to ensure that they are in service through their design life spans. This can be done by considering road pavement failure from the early stage when it is even not visible or obvious to the user. This requires professionalism and the use of technical procedures has been recommended in this paper. This is because most of us drive and road pavement failure to us is simply the appearance of deep gapping potholes on our highways. But the truth is that this represents the worst and ultimate deterioration of the roadway because the failure of the pavement should have long been detected and remedied before reaching such an appalling condition.

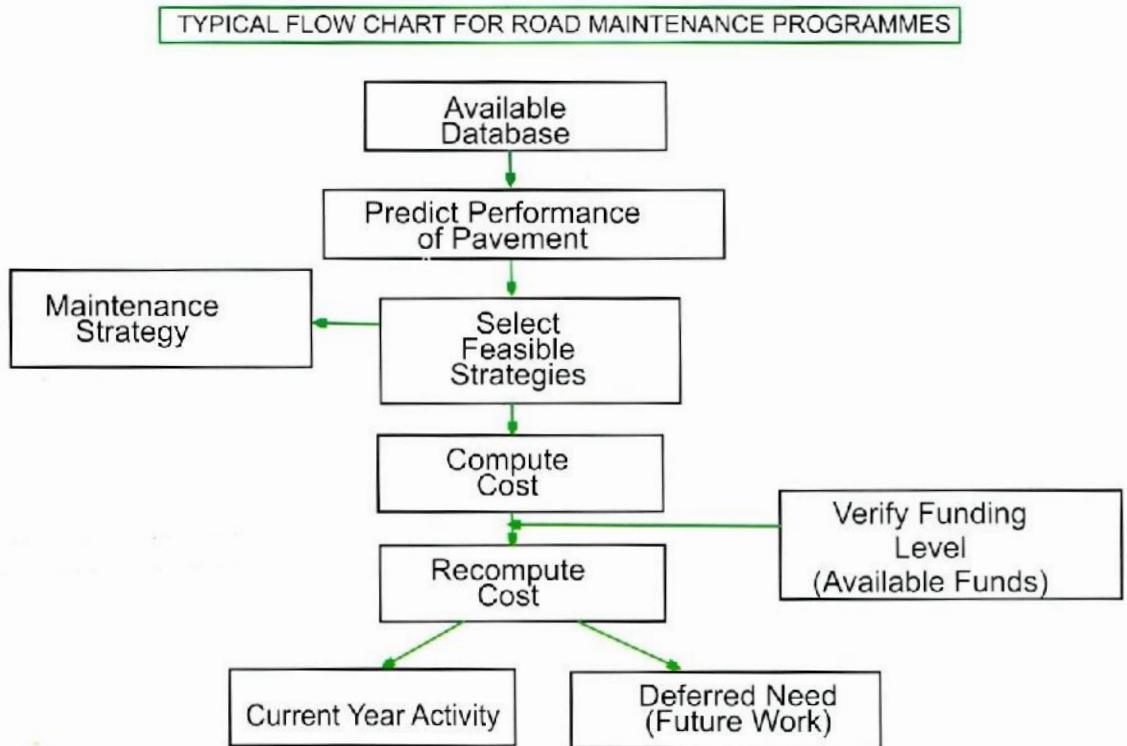
Figure 4: A typical flowchart for road maintenance programmes

A typical flowchart for road maintenance programmes is shown in Figure 4. Adherence to the flow chart has been limited by paucity of quantitative data on road condition and predicted performance parameters. This is now being addressed through road condition surveys such as pavement structural strength survey using Falling Weight Deflectometer (FWD), Dynamic Cone Penetrometer test, and Road Roughness survey using ROMDAS to complement qualitative data from annual road visual inspection. However, locating historical data relating to as built records, construction age, loading history, initial cost, maintenance records, remain a challenge.

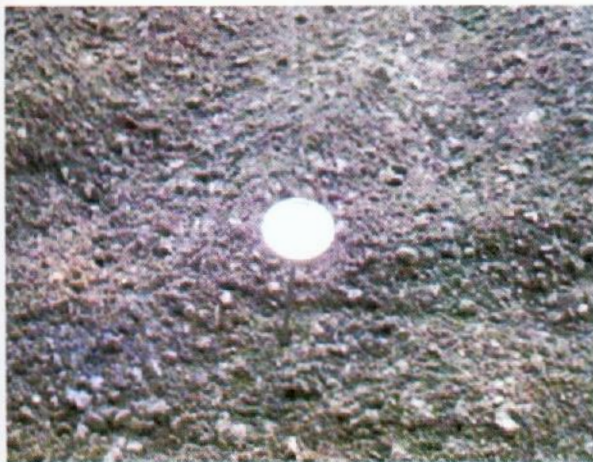
Photo 5 – A Thermometer for measuring temperature of laid asphalt

LOPEK Construction Ltd claims that asphalt is loaded from the asphalt plant at 140°C temperature and it is laid at 130°C temperature. At the Lagos State Asphalt Plant, asphalt is said to be produced at 110 – 130°C temperature range, and rolled at 90°C. Very few road contractors/road maintenance agencies bother to measure the temperature of the asphalt before it is laid and before rolling operations. Though, a company such as LOPEK LTD claims to have gauge to measure asphalt temperature on site, only Julius Berger has been found to always consistently check for temperature (see Photos 5 & 6)

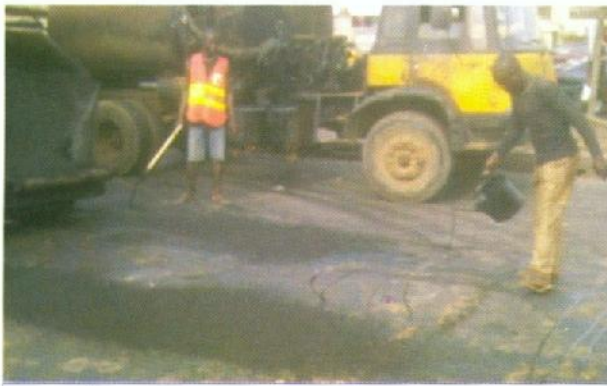
Quantities of the tack coat are also poured into spray cans and manually applied to portions of the pavement surface that are not covered by the mechanical spraying operation. This manual method of tack coat application is also employed for surface portions where the bitumen heater's nozzles cannot extend to such as junctions (see Photo 15). The application is done rather sparingly and the effectiveness is definitely in doubt. This would lead to early manifestation of distress (such as slippage cracking) in such areas due to non-bonding between the old and newly-laid asphalt.

Photo 15 – Applying tack coat to a junction pavement surface using spray can

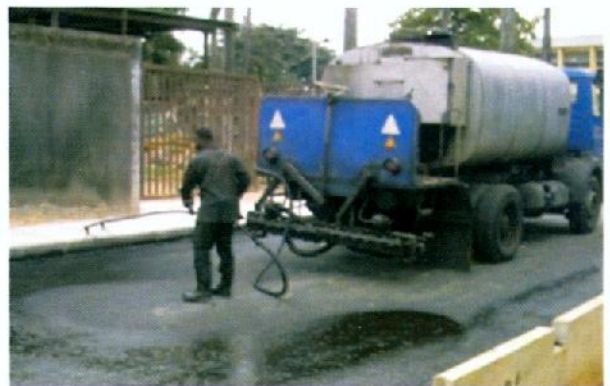
Photo 16 – Spraying tack coat using an extended pressure nozzle

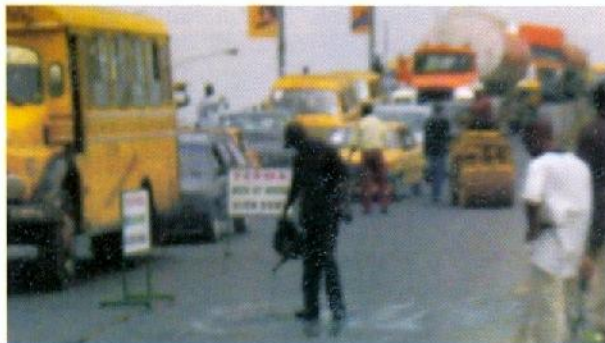
It is customary to carry out small-scale patch of defects such as potholes, prior to spraying the tack coat and laying the wearing course. Quantities of the asphalt are taken directly from the truck, placed in the affected areas, raked to level and then compacted with the aid of the vibratory roller (see Photos 17-20).

Photo 17 – Applying tack coat over localized distressed areas to be patched

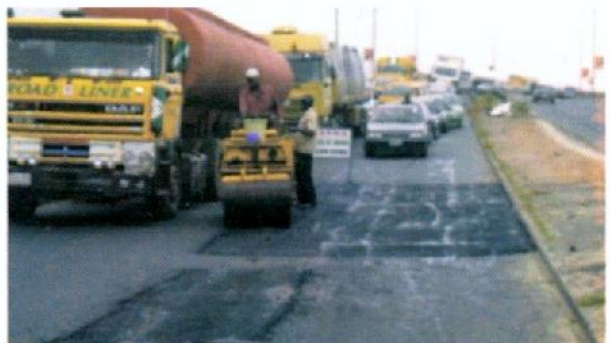
Photo 20 – Compacting patches with vibratory roller

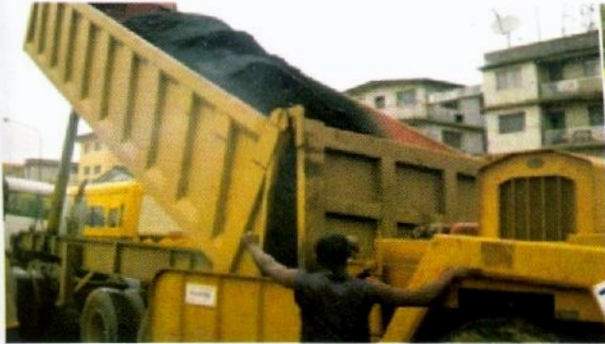
Immediately after spraying the tack coat over the pavement stretch, the paver is positioned to receive asphalt from the tipper lorry and commence laying the asphalt (see Photos 21 & 22). Conventionally, a pavement overlay of 40-50mm thick HMA (after compaction) is used for major roads in the country. To achieve the 50mm thickness, the paver's screws are adjusted to lay 75mm of loose lift thickness of asphalt.

Photo 21 – Tipping stockpiled asphalt into the paver bucket

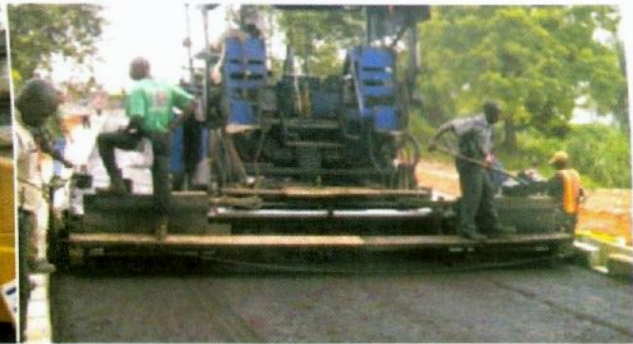
Photo 22 – An asphalt paver laying fresh asphalt wearing course

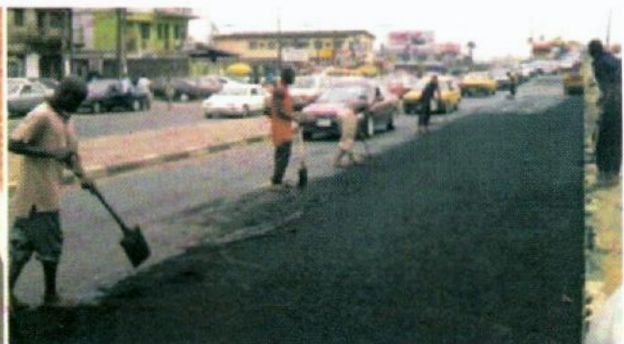
Photo 24 – Using shovels to rake freshly-laid asphalt to level

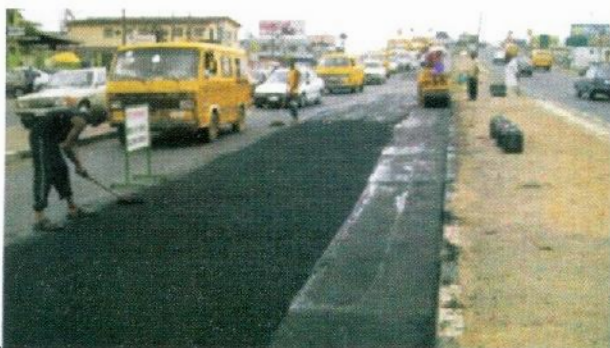
The final step in this rehabilitation process is to compact the laid asphalt wearing course to the required density. This is commonly achieved using steel drum vibratory rollers (see Photos 25 & 26). The required density is expected to be achieved after five passes of the roller. The roller makes two passes initially while the asphalt is still hot and makes the remaining three passes after the asphalt has cooled sufficiently.

Photo 25 – Commencement of compaction of freshly-laid asphalt concrete

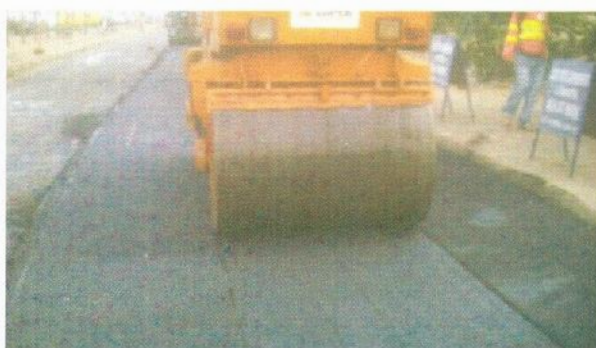
Photo 26 – Compacting freshly-laid asphalt using vibratory steel drum roller

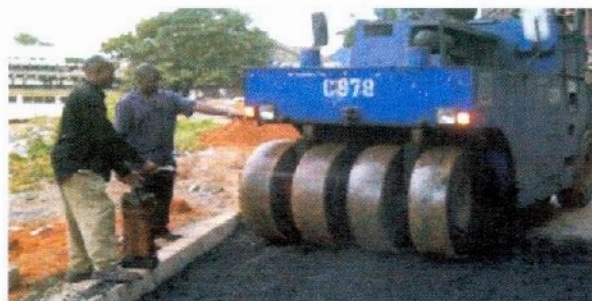
A pneumatic-tyre roller (see Photo 27) should then be used to finish the compaction process, principally to achieve smoothness. It has been observed that most contractors and road maintenance agencies do not carry out this aspect of the work. However, large-scale companies like Julius Berger Construction Ltd., has been observed to finish their compaction process with pneumatic rollers.

Photo 27 – Finish-compaction of freshly-laid asphalt using pneumatic-tyre roller

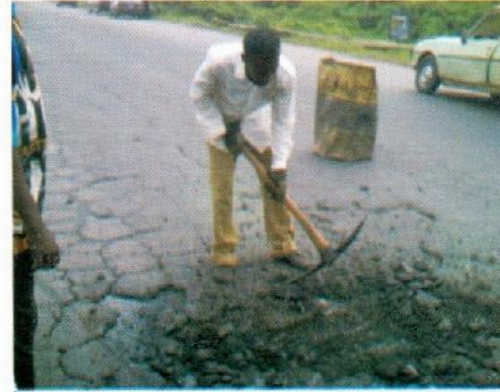
Photo 31 – Using digger to dig out cracked portions of road.

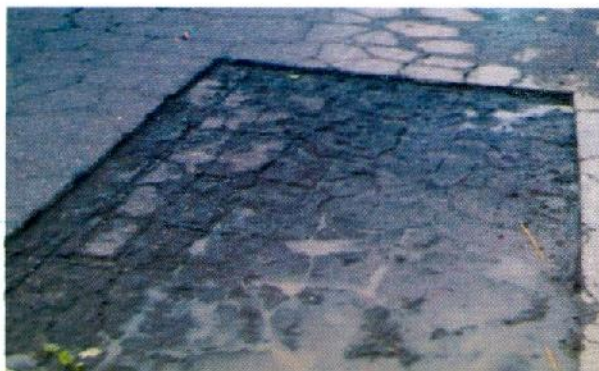
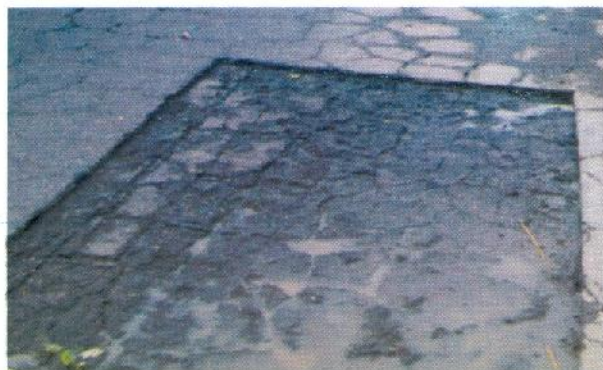
Photo 32 – Close-up view of scarified pavement down to binder course level only.

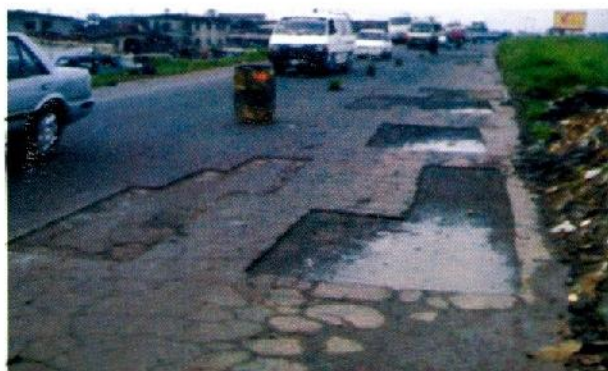
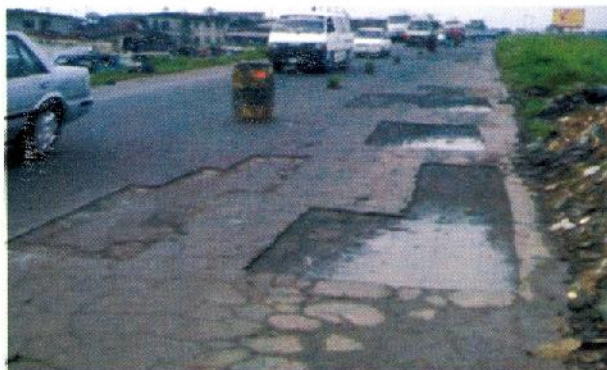
Photo 33 – Selective scarification of pavement sections. Areas not scarified will not be repaired.

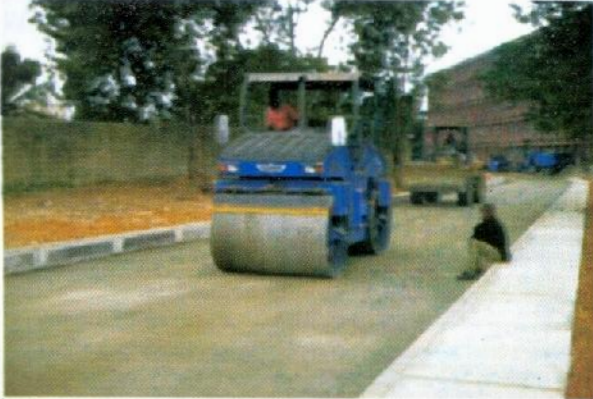
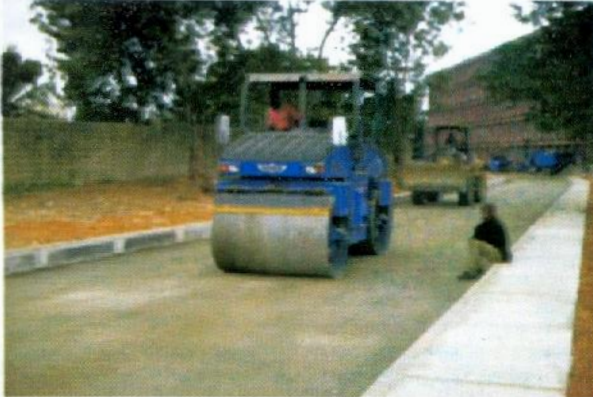
- (ii) Lateritic soil or ¾"-size stone base is now placed to replace the scarified base course. Lateritic soil (when used) is hardly tested to determine its CBR percentage, nor is the soil ever stabilized. However, if stone base material is used for the base course, the CBR is expected to be a minimum of 80%. The newly-placed base course is then compacted with soil vibratory rollers, up to 150mm depth.

Photo 36 – Compacting stone base with vibratory roller (Courtesy: Julius Berger Nig. Ltd.)

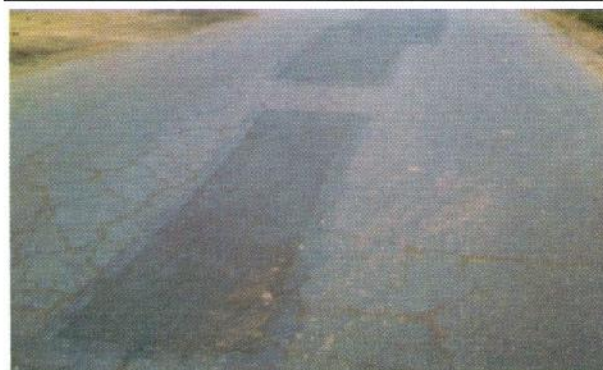
Photo 34 – Bird's eye view of rehabilitated road section. Note the existence of medium severity alligator cracks around rehabilitated area

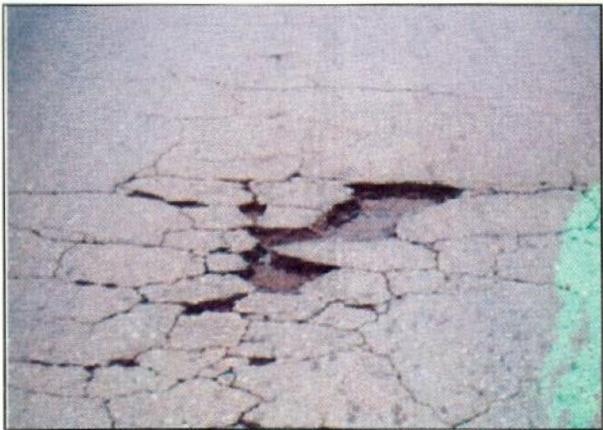
PLATE 3: High severity alligator cracks with the loosening of the pieces of asphalt

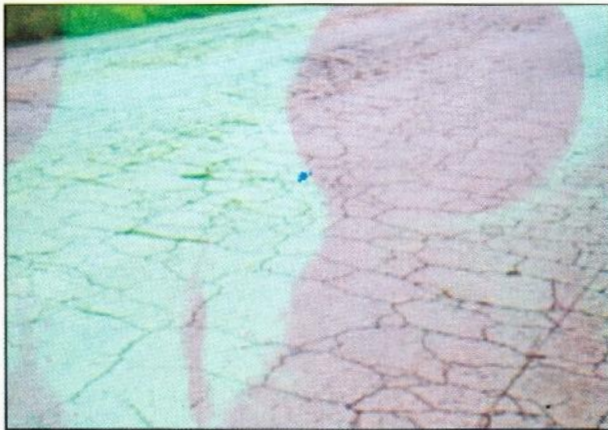
PLATE 4: High severity alligator cracks

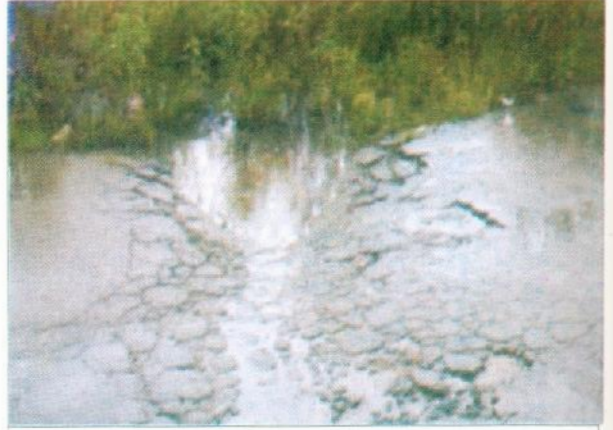
PLATE 8: Structural failure due poor drainage design at the footslope of the road

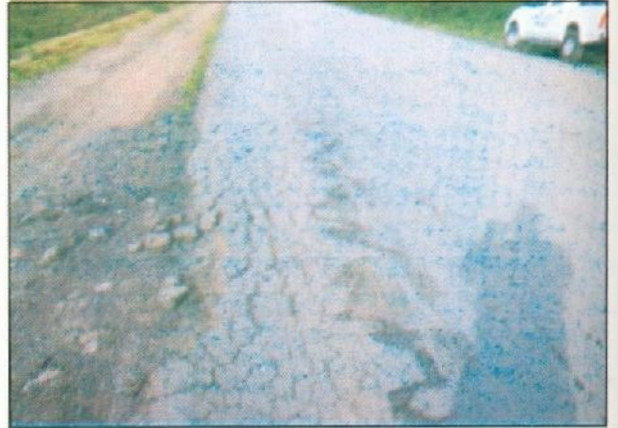
PLATE 10: High severity longitudinal cracks on the edge of the pavement due to undercutting by erosion, Enugu Bound lane

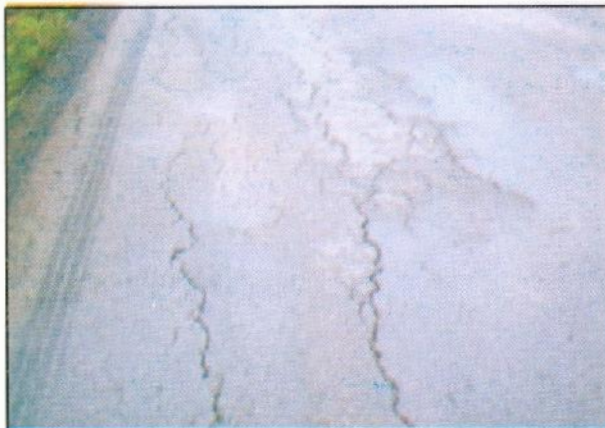
PLATE 11: Moderate severity longitudinal cracks on the wheelpath of the road

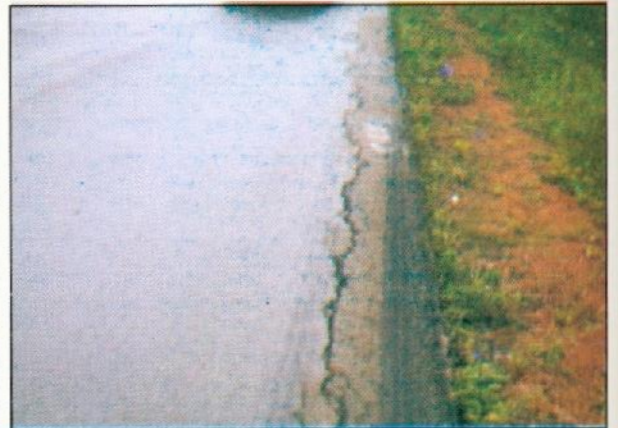
PLATE 12: Low severity longitudinal crack at the edge of the road
