PROCEEDINGS OF NATIONAL TECHNICAL WORKSHOP ON BUILDING COLLAPSE IN NIGERIA

**CURBING THE INCIDENCES OF
BUILDING COLLAPSE IN NIGERIA**

HELD AT SHERATON ABUJA HOTEL, NIGERIA

15TH-16TH MAY 2012

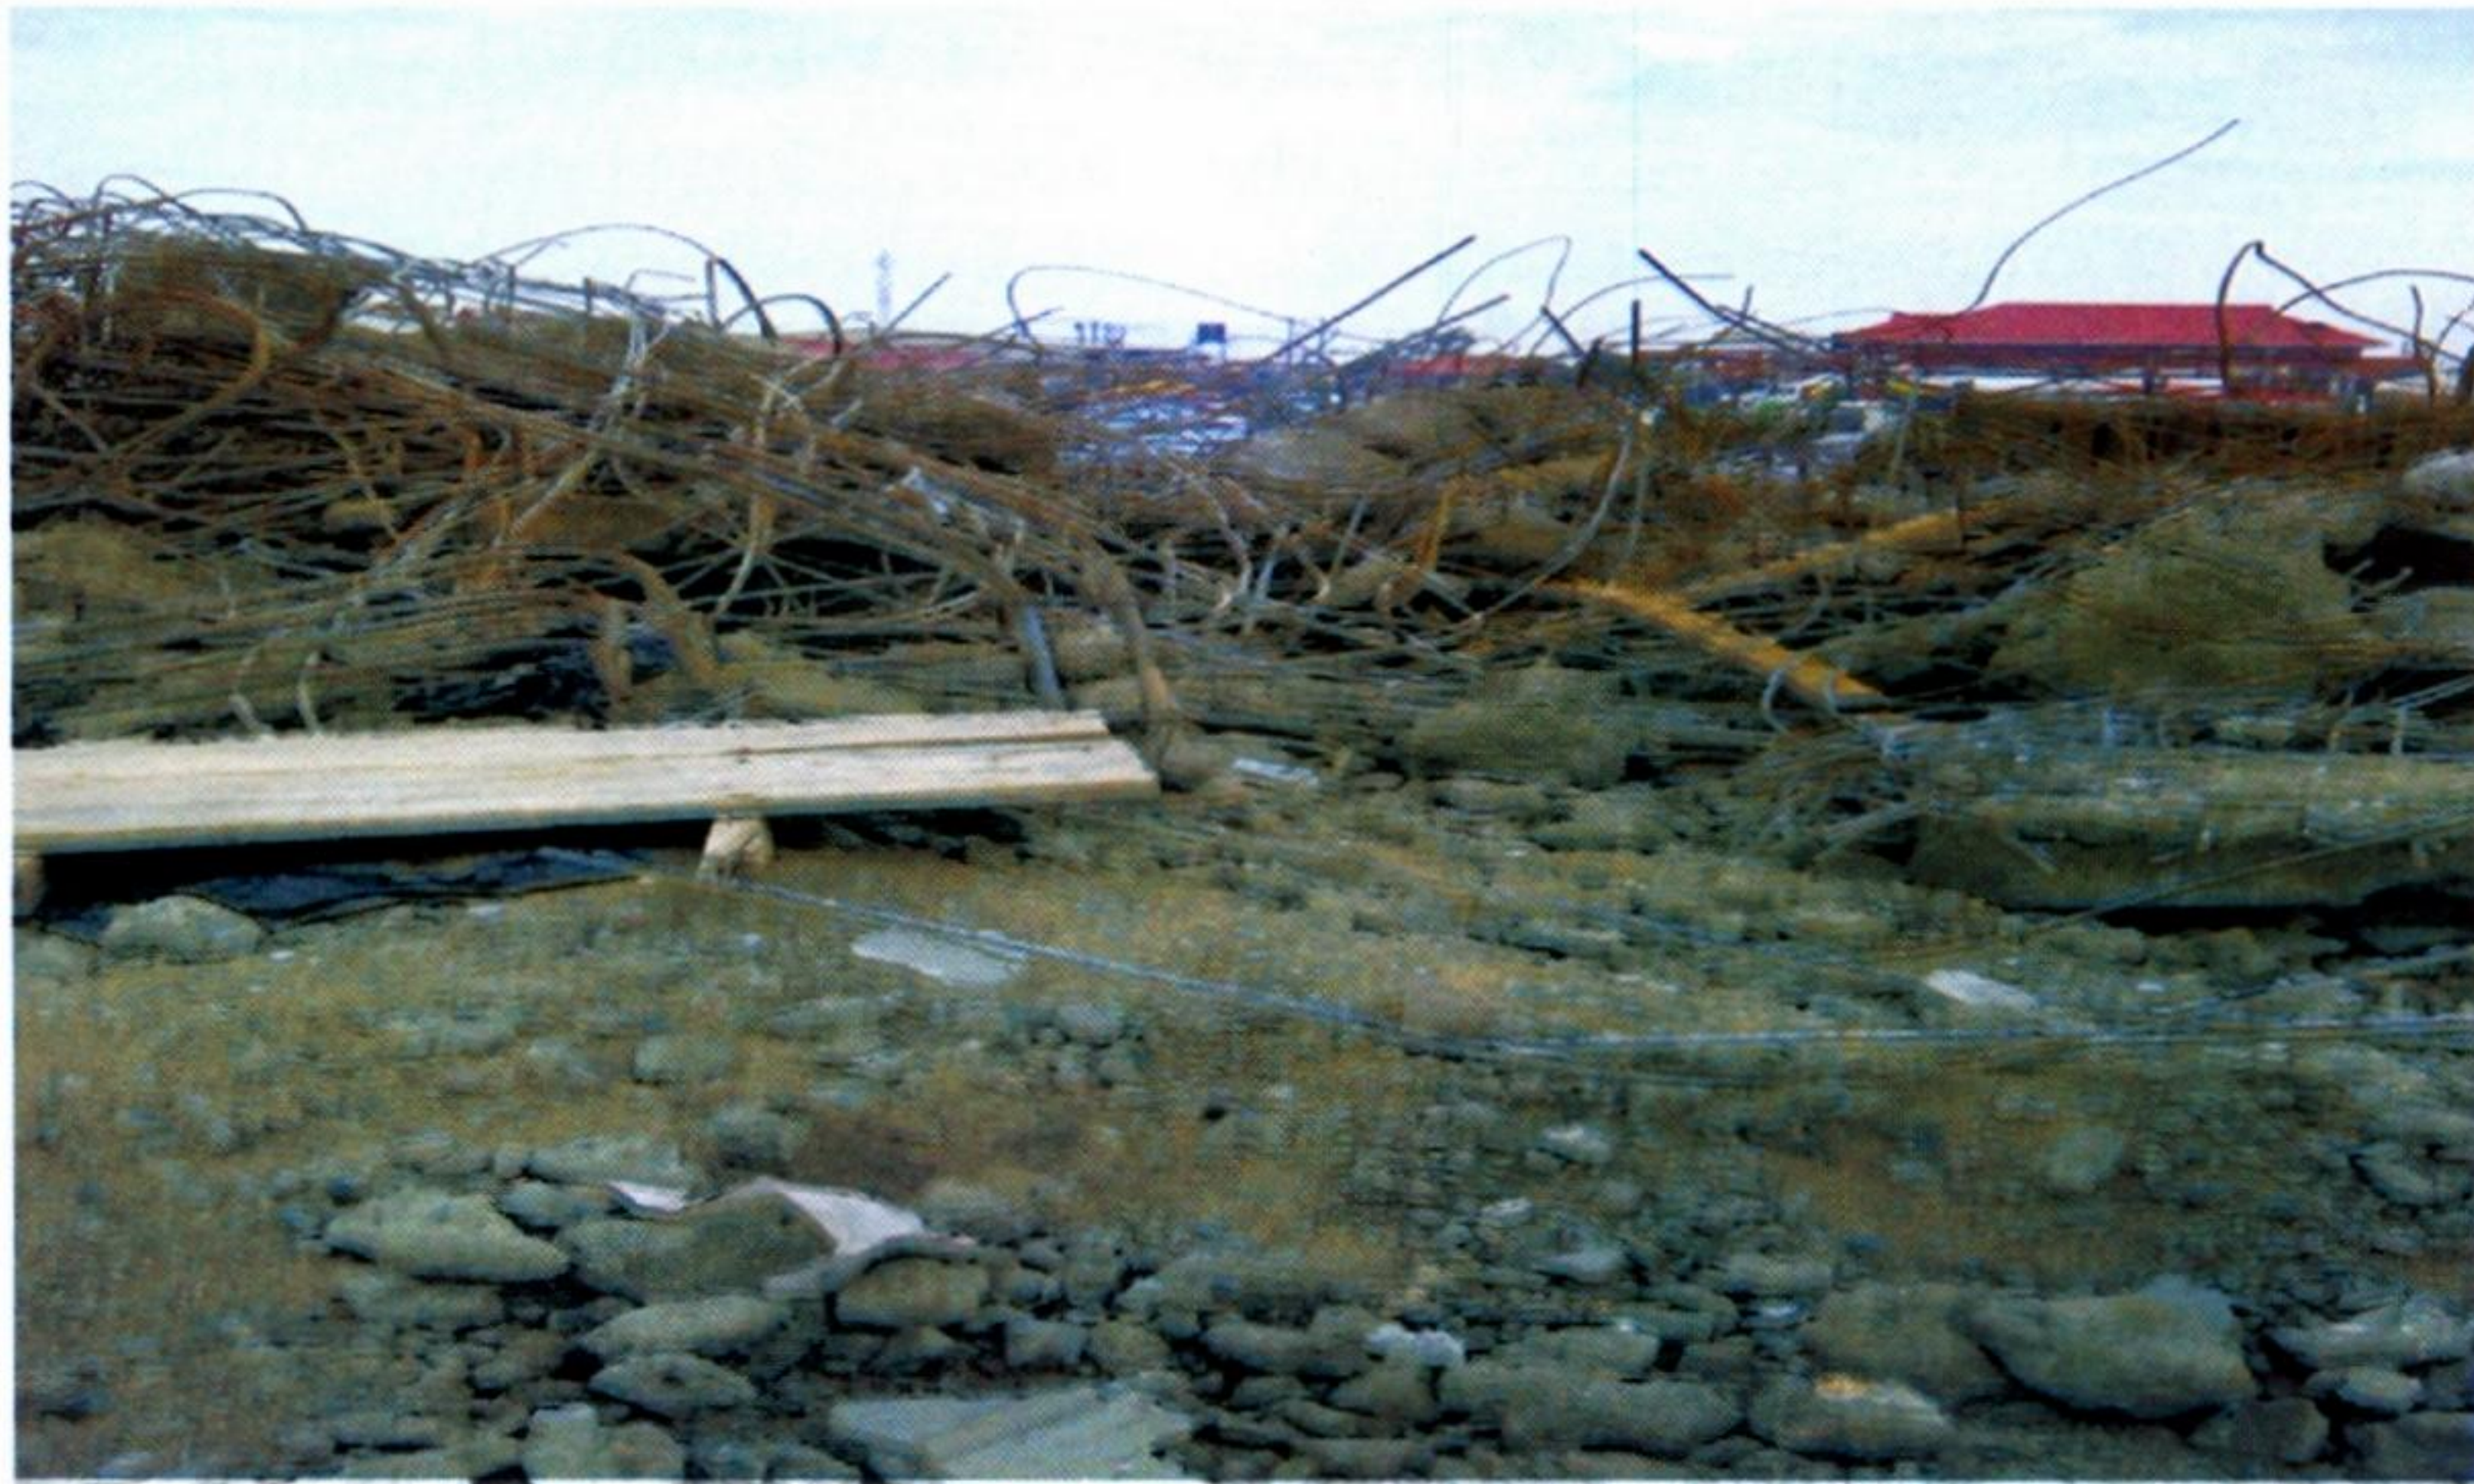
Figure 4: Disintegrated Building, Mararaba, Abuja outskirts, 5th July 2011

(example, deficiencies of foundations, columns, beams or other structural elements), the failure of structures by explosion denote that there was poor concreting on site. Indeed, results measured on sites by NBRRI in the last one year have confirmed this assertion, as presented in Table 1 below, extracted from Technical Report No.23. The ultrasonic Pulse velocity tests were used for the determinations, which is a non-destructive test acceptable for lump specimens from the site of the collapsed structure. In fact, NBRRI Technical report No.22 had categorically asserted that the failure of one of the structures investigated was by rapid disintegration of concrete elements and almost transformation of sandcrete blocks into sand.

NBRRI Technical Report No.22 clearly identified poor concreting, low design mix ratio, lack of adequate OR improper curing, large impurities and organic matter in fine aggregates (sand) used for concrete batching, etc., in the inspected specimens of the collapsed building at Mararaba on the outskirts of Abuja.

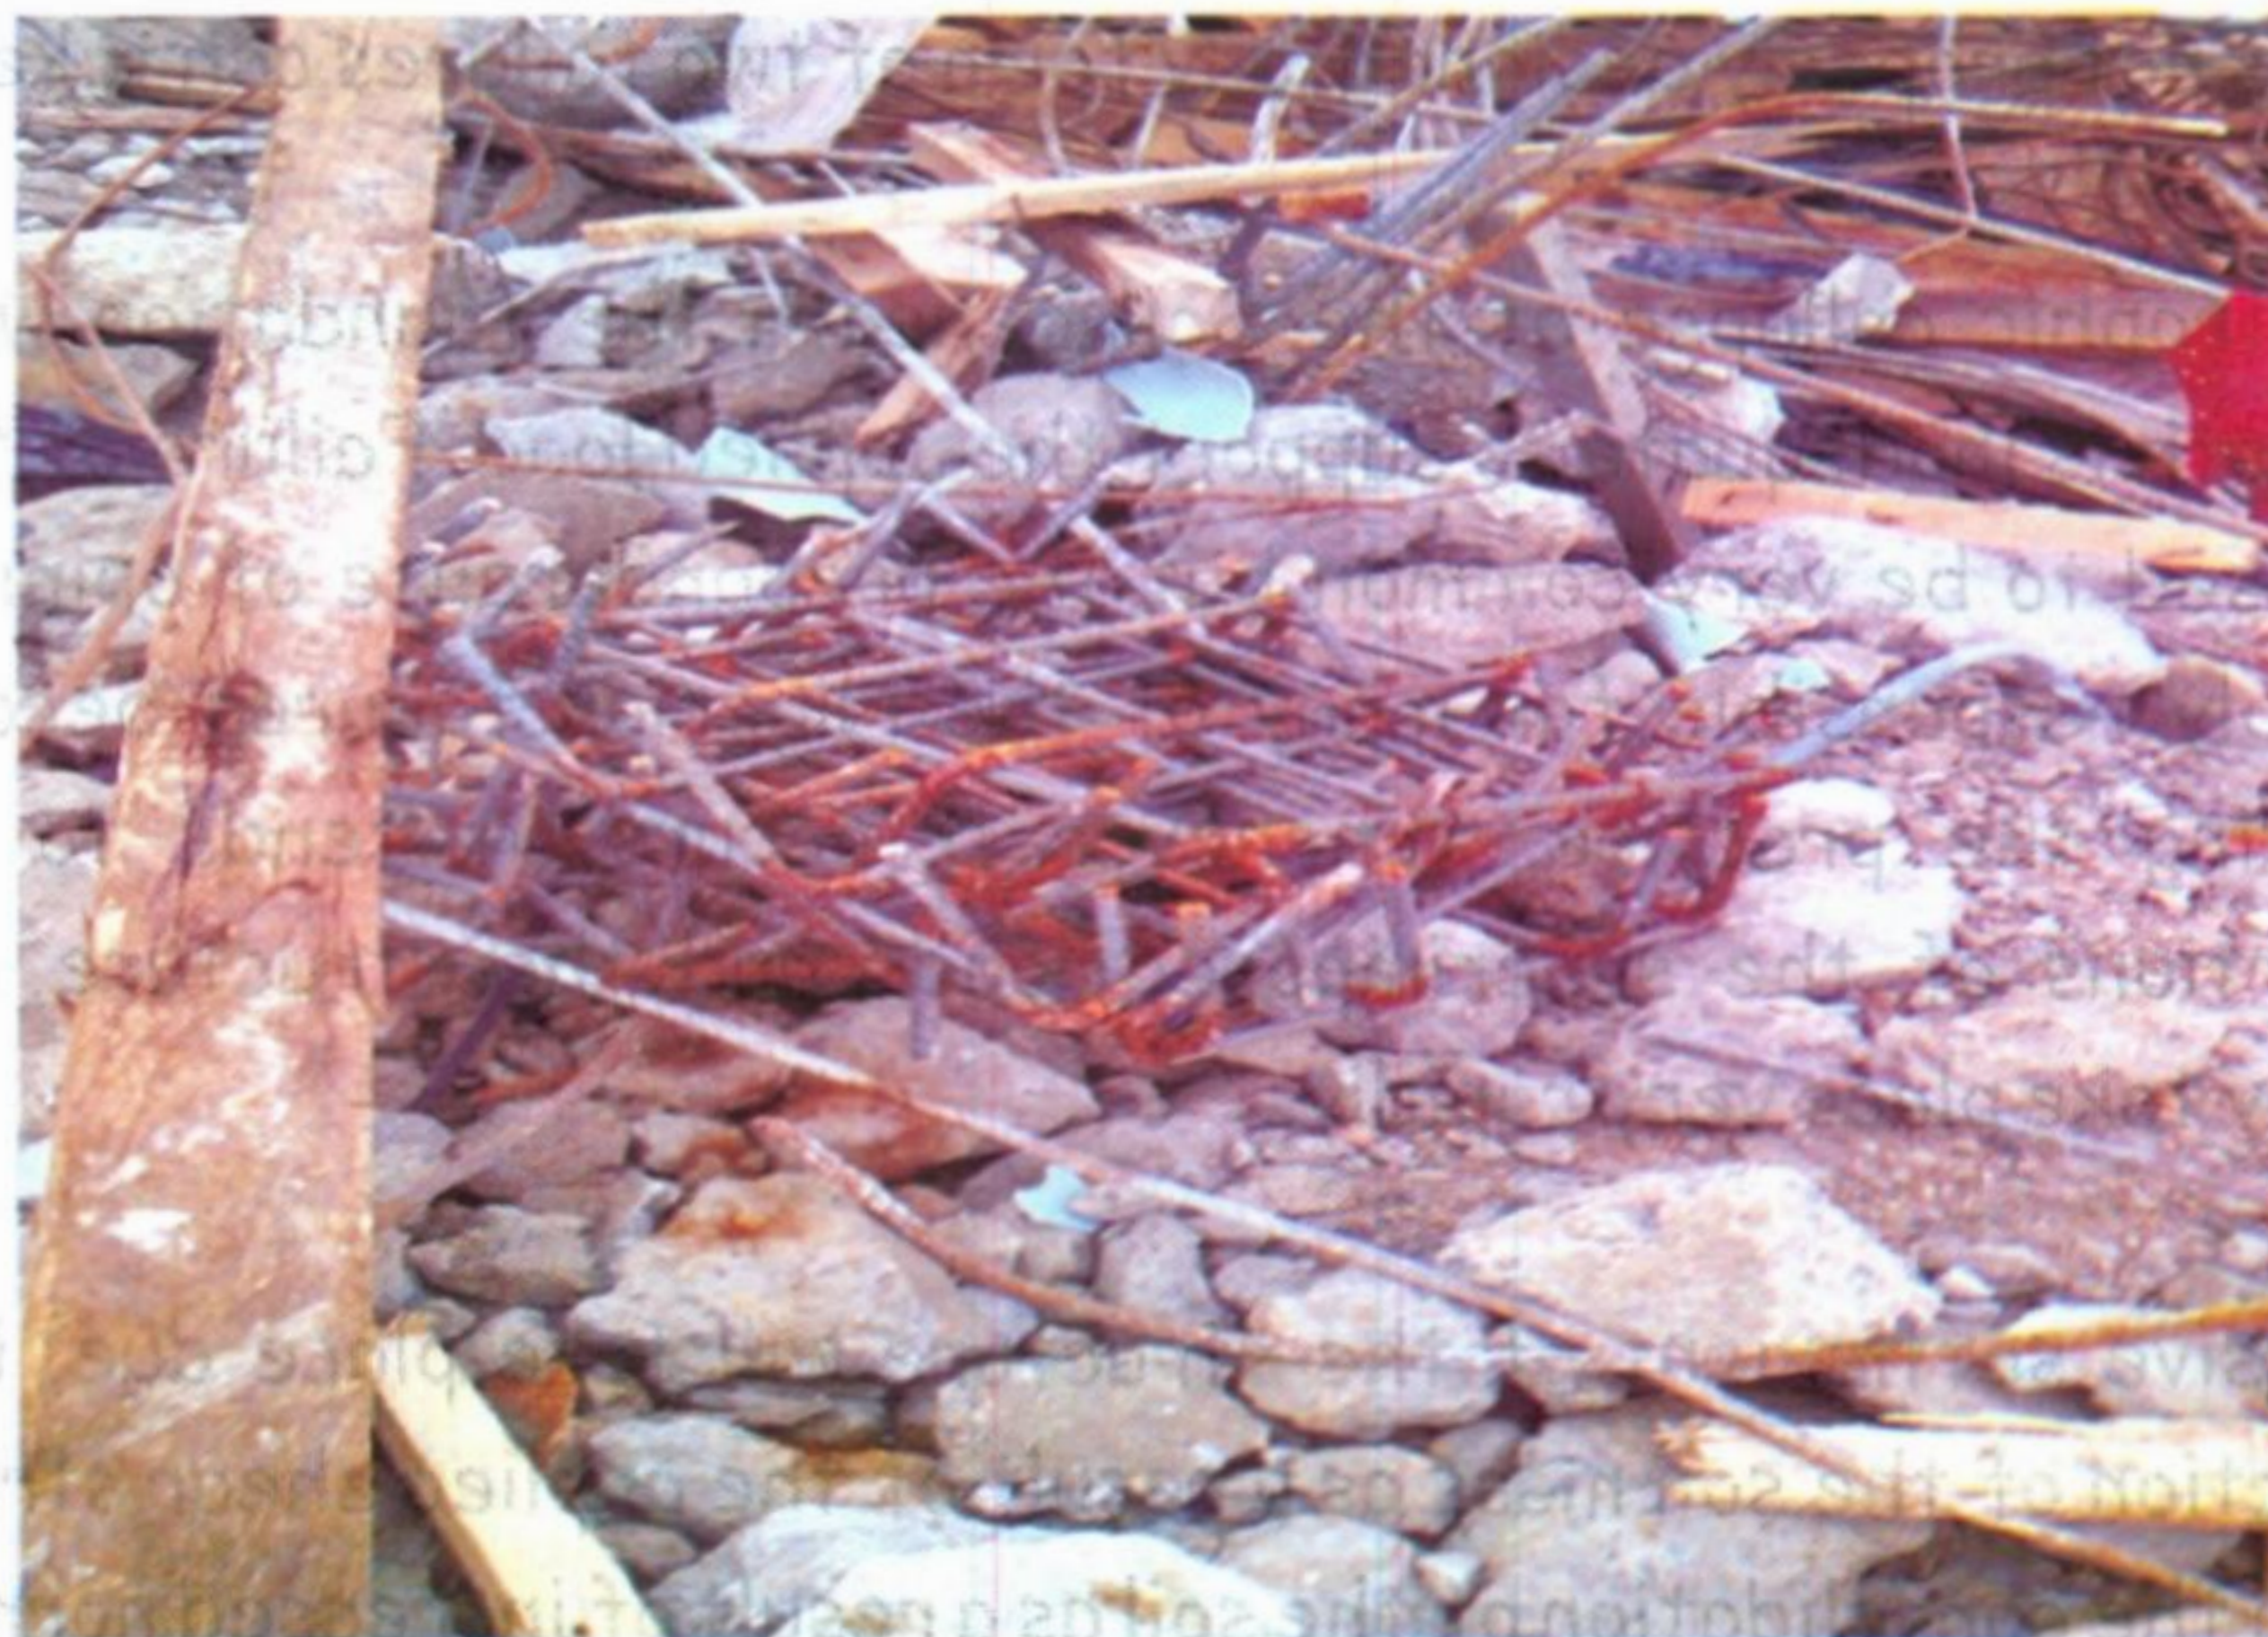
Figure 6: Mararaba Collapsed Site Showing Footing Reinforcement clearly under-sized (450mmx450mm)

The terminology used (though primarily for strip footings beneath the building walls) for foundations in Nigeria is blinding which is grossly misleading because it could be responsible for many of the collapses. This is because 'Blinding' is the process of ground preparation in order to provide an even surface upon which the actual foundation of the structure can be built. It is made of lean concrete and will never exceed 50mm thick whereas the minimum thickness of a structural

foundation (even for nominal situations below a wall) is 150mm prepared using concrete grade 25.

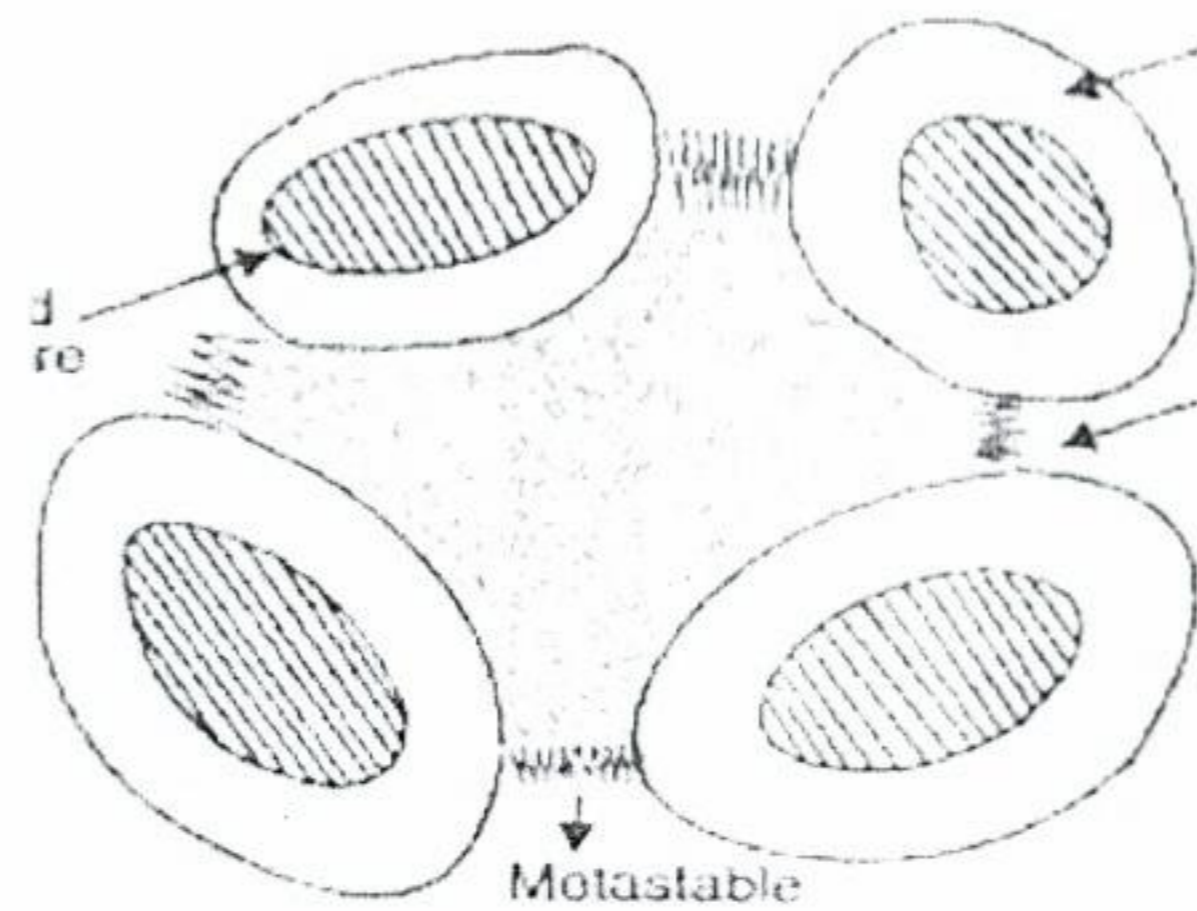
Figure 9: Microscopic schematic model representing the structure of hardened cement paste.

Figure 9 represents the microscopic schematic model of structure of hardened cement paste. C_3S requires 24 percent of water by weight of cement and C_2S requires 21 percent. It has also been estimated that on an average 23 percent of water by weight of cement is required for chemical reaction with Portland cement compounds. This 23 percent of water chemically combines with cement and, therefore, it is called bound water. A certain quantity of water is imbibed within the gel-pores, this water is known as gel-water. It can be said that bound water and gel-water are complimentary to each other. If the quantity of water is inadequate to fill up the gel-pores, the formations of gel itself will stop and if the formation of gel stops there is no question of gel pores being present. It has been further estimated that about 15 percent by weight of cement is required to fill up the gel-pores. Therefore, a total 38 percent of water by weight of cement is required for the complete chemical reactions and to occupy the space within gel-pores.

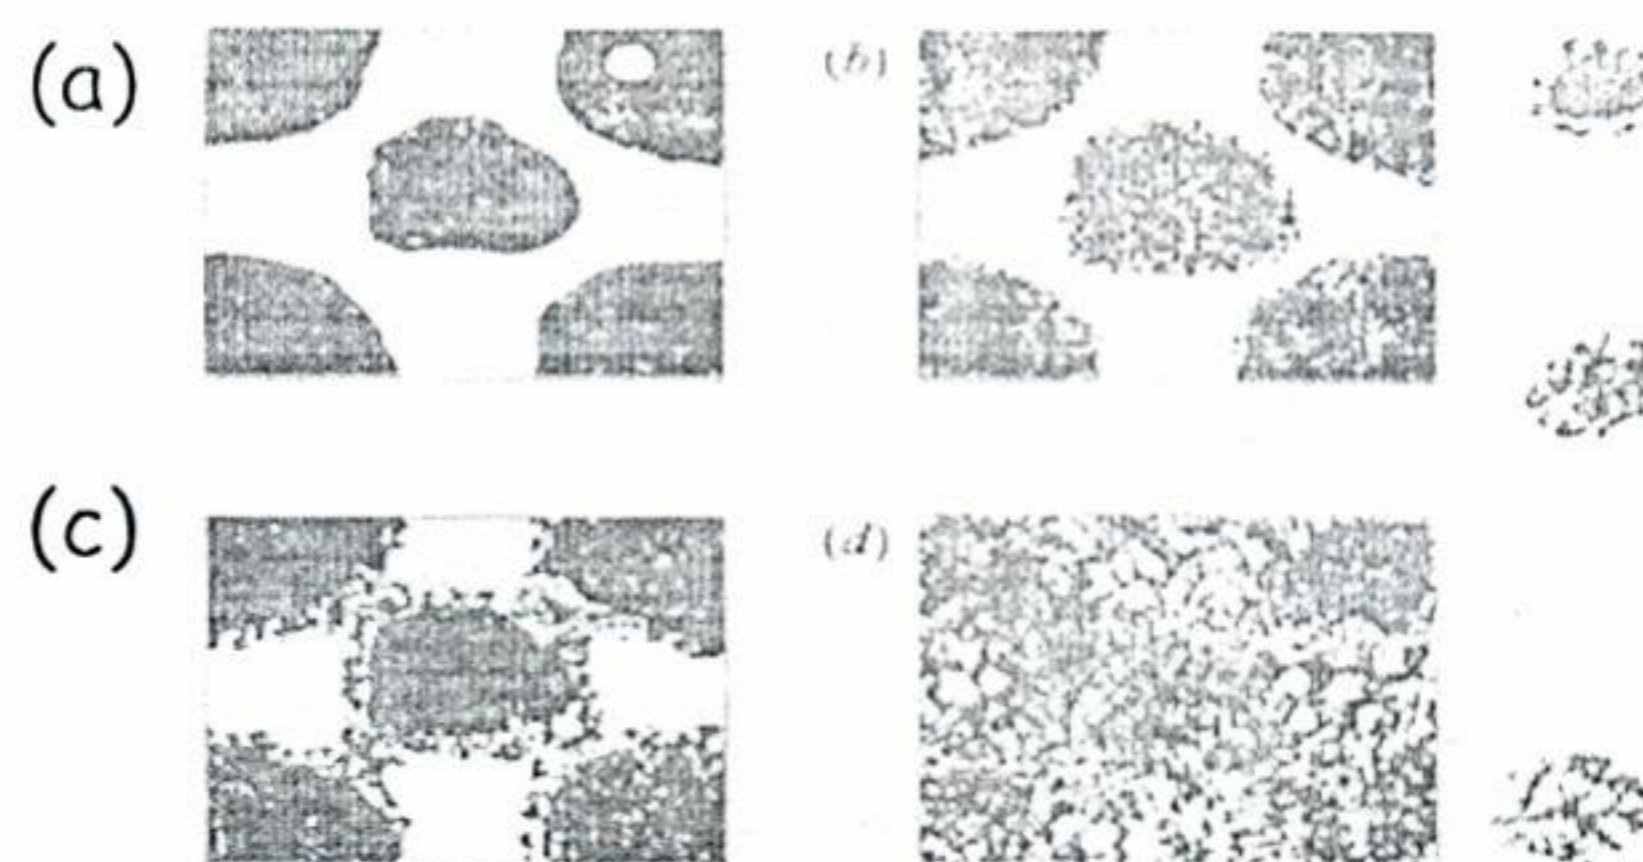
Unhydrated cement particles
Cement gel Capillary pores and cavities

Fig. 10: Diagrammatic representation of the hydration process and formation of cement gel

If water equal to 38 percent by weight of cement is only used, it can be noticed that the resultant paste will undergo full hydration and no extra water will be available for the formation of undesirable capillary cavities. On the other hand, if more than 38 percent of water is used, then the excess water will cause undesirable capillary cavities.

Therefore, the greater the water above the minimum 38 percent required used, the more will be the undesirable capillary cavities. In all these, it is assumed that hydration is taking place in a sealed container, where movement of moisture to and from the paste does not take place. It can be seen that the capillary cavities become larger with increased water/cement ratio. With lower w/c ratio the cement particles are closer together. With the progress of hydration, when the volume of anhydrous cement increases, the product of hydration also increases. The increase in the volume of gel due to complete hydration could fill up the space earlier occupied by water up to a w/c ratio of 0.6 or so. If the w/c ratio is more than 0.7, the increase in volume of the hydrated product would never be sufficient to fill up the voids created by water and such concrete would ever remain as porous mass. This is to say that gel occupies more and more space that was once occupied by mixing water. It has been estimated that the volume of gel would be about twice the volume of unhydrated cement.

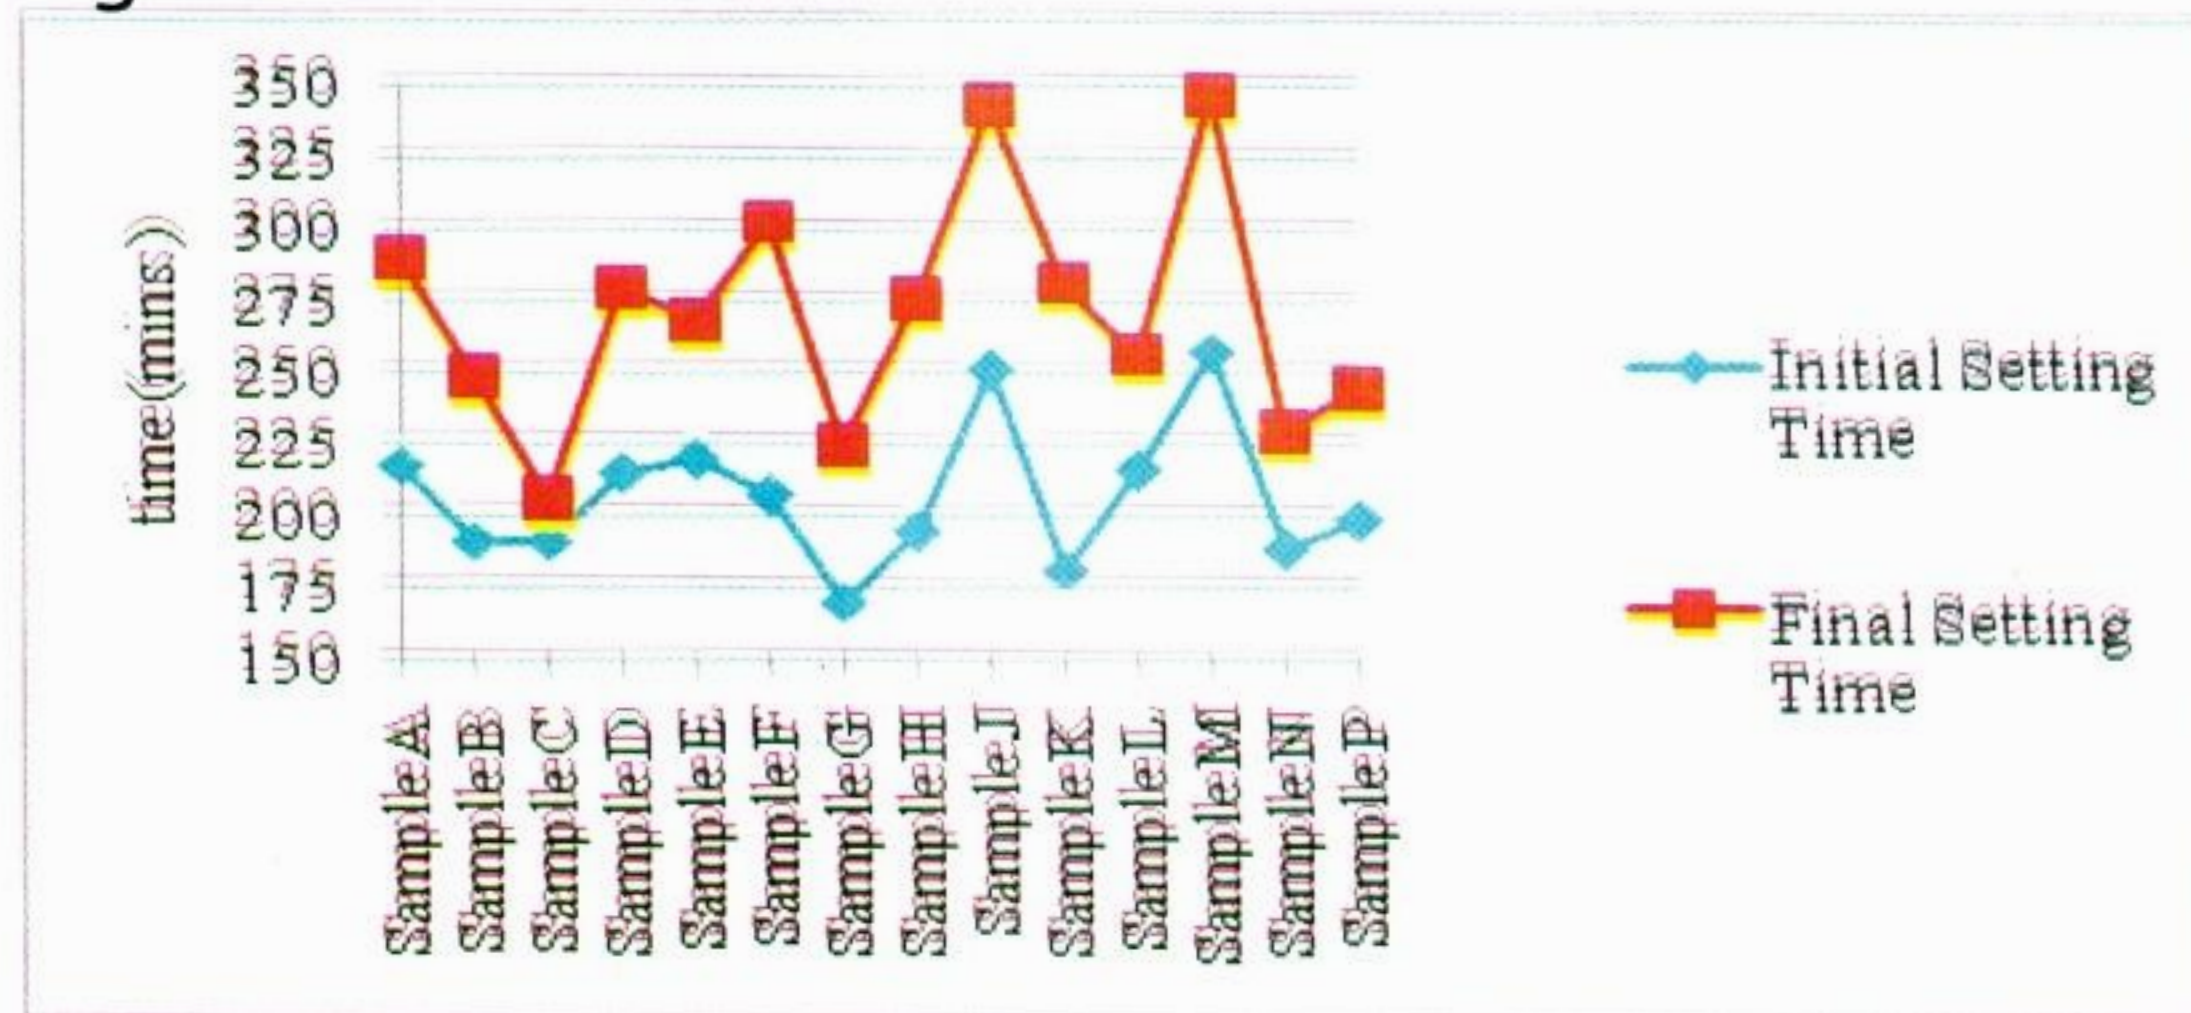
Figure 11: Consistency test results

4.2.1 Standard Consistency test: Though the initial and final setting time do not in any way determine the strength property of cement; it serves to give engineers a guide to water/cement ratio adjustments in mixes. Cements which had high Specific Surface Areas and low ($45\mu m$) residues were found to require more water and vice versa. Cement Sample M had the highest initial and final setting time of

258 and 343 minutes respectively while cement Sample G had the least initial setting time of 171 minutes, Sample C was also observed to have the least final setting time of 203 minutes while it had the least interval between the initial and final setting time. All the cement brands assessed met the SON requirements with regards to initial setting time; ≥ 75 minutes for cements of strength class 32.5 N/mm² and ≥ 60 minutes for cements of strength class 42.5 N/mm². This is illustrated in Figure 11.

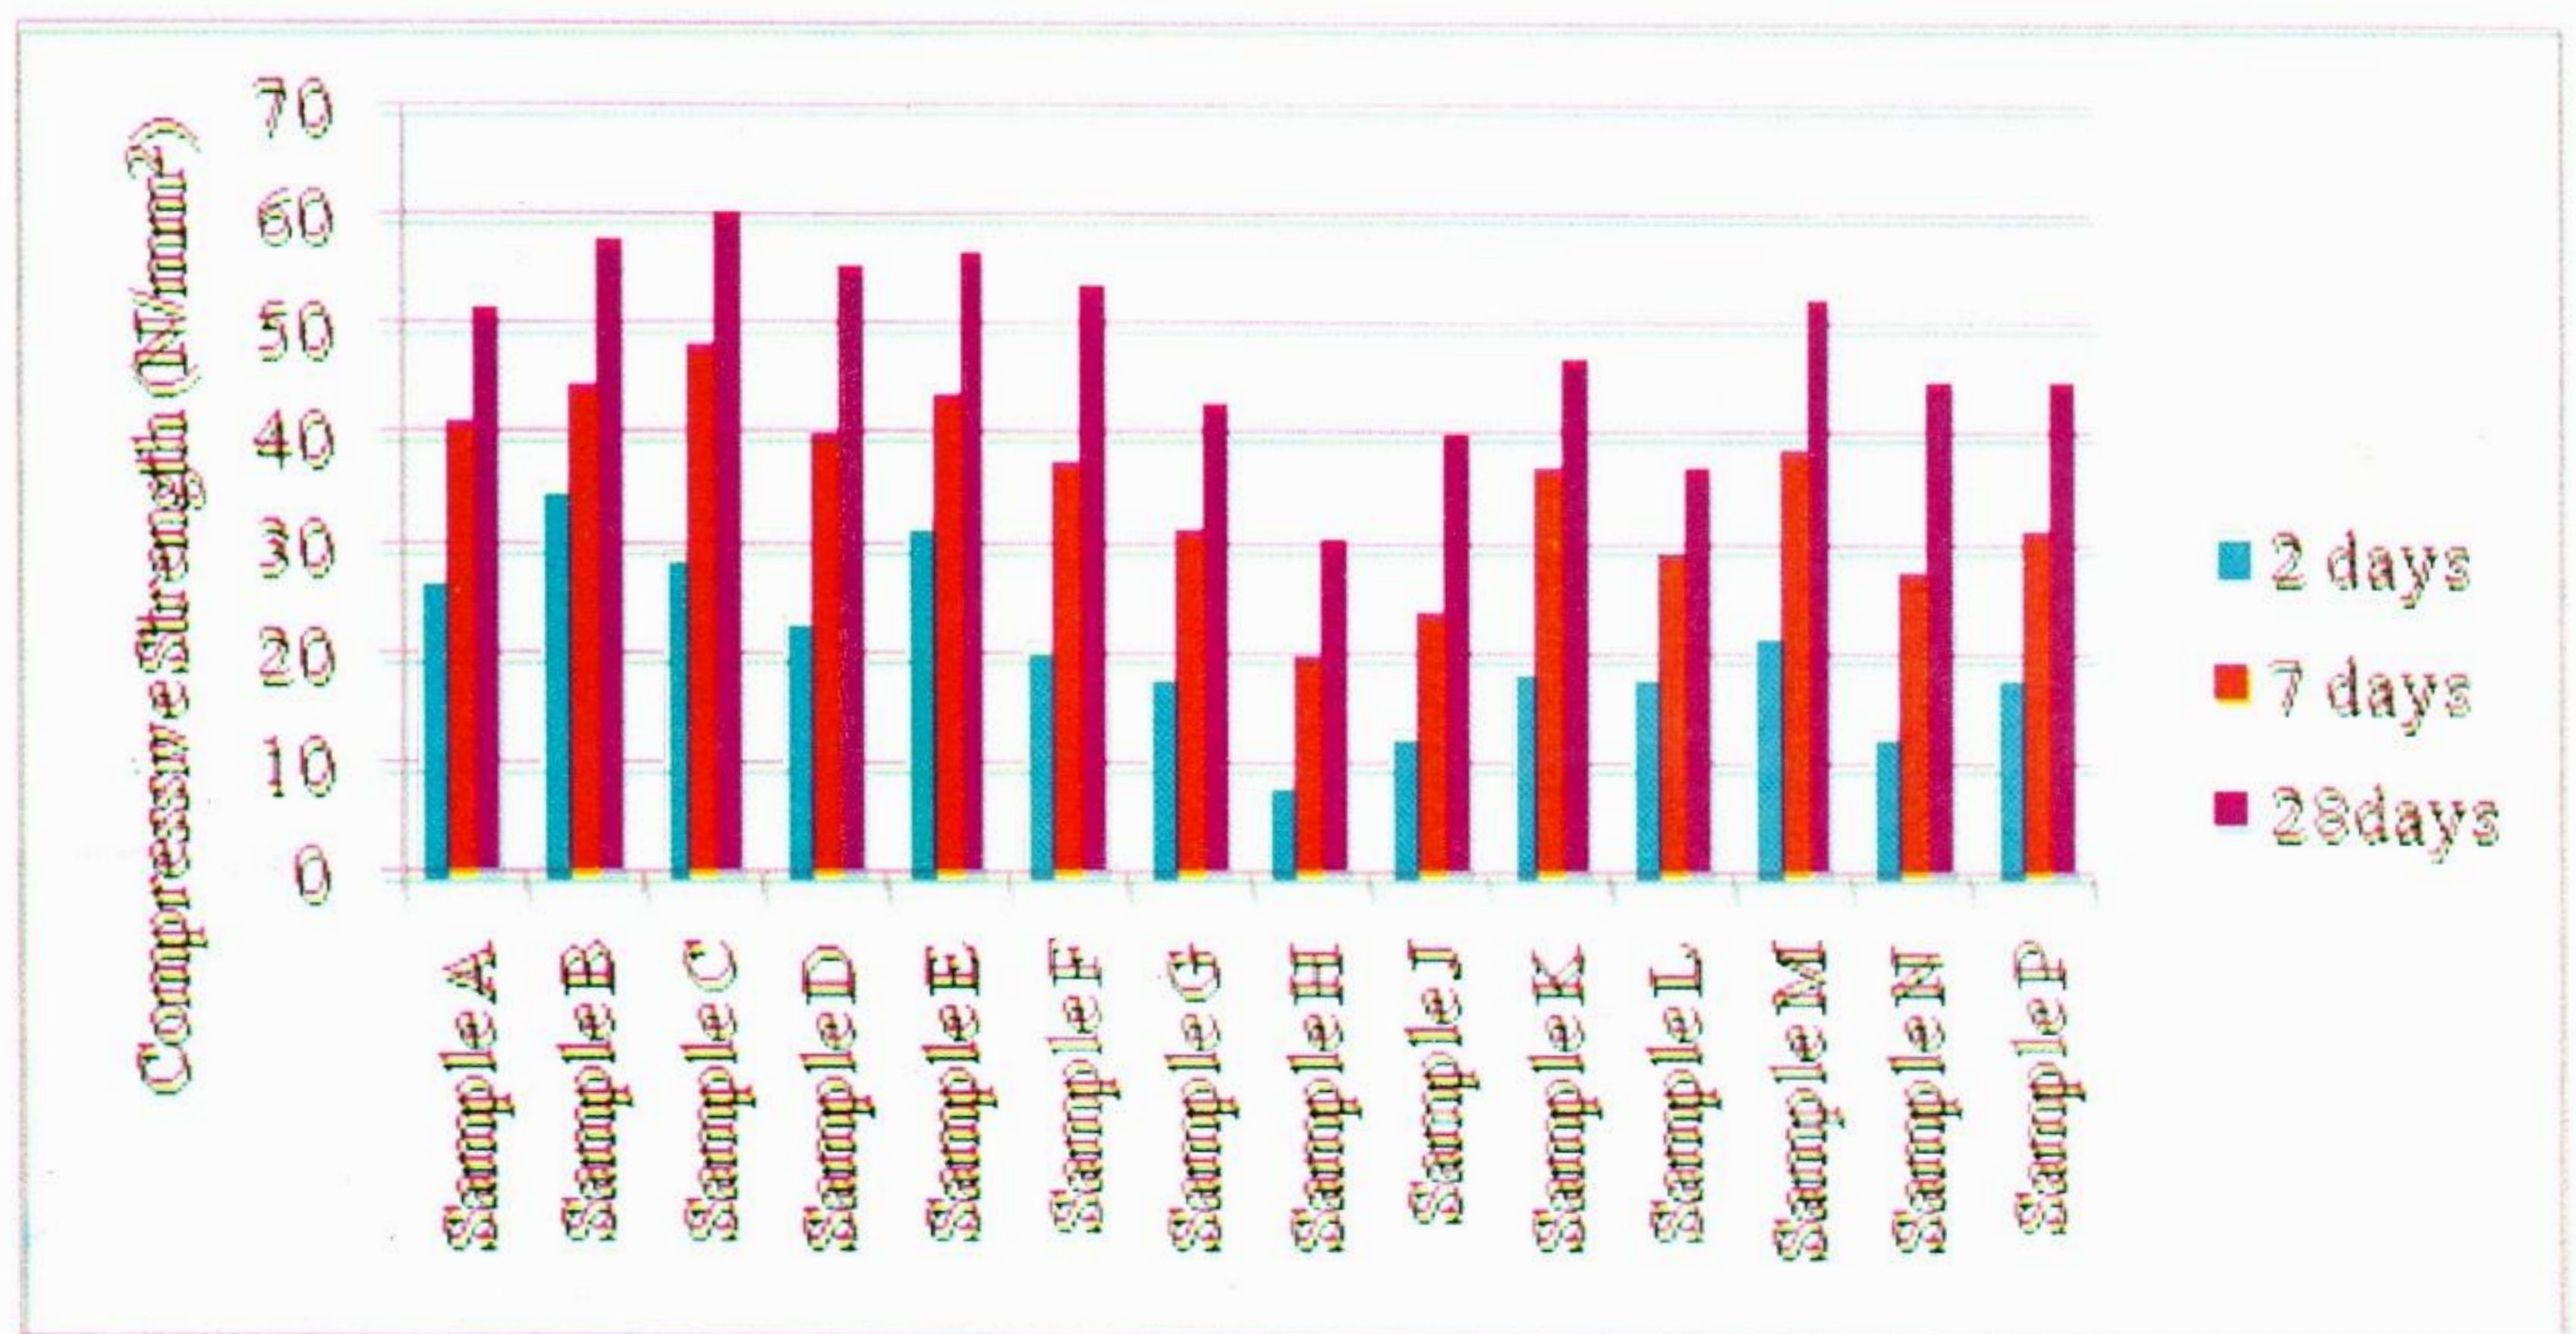
Figure 12: Cement Compressive Strengths.

4.2.2 Strength Test: From results obtained, Sample H was the only brand which failed to meet the required standard strength of ≥ 10 N/mm² at 2 days and ≥ 32.5 N/mm² at 28 days. All other cement brands met the required Nigerian standard.
