PROCEEDINGS OF NATIONAL TECHNICAL WORKSHOP ON BUILDING COLLAPSE IN NIGERIA

**CURBING THE INCIDENCES OF
BUILDING COLLAPSE IN NIGERIA**

HELD AT SHERATON ABUJA HOTEL, NIGERIA

15TH-16TH MAY 2012

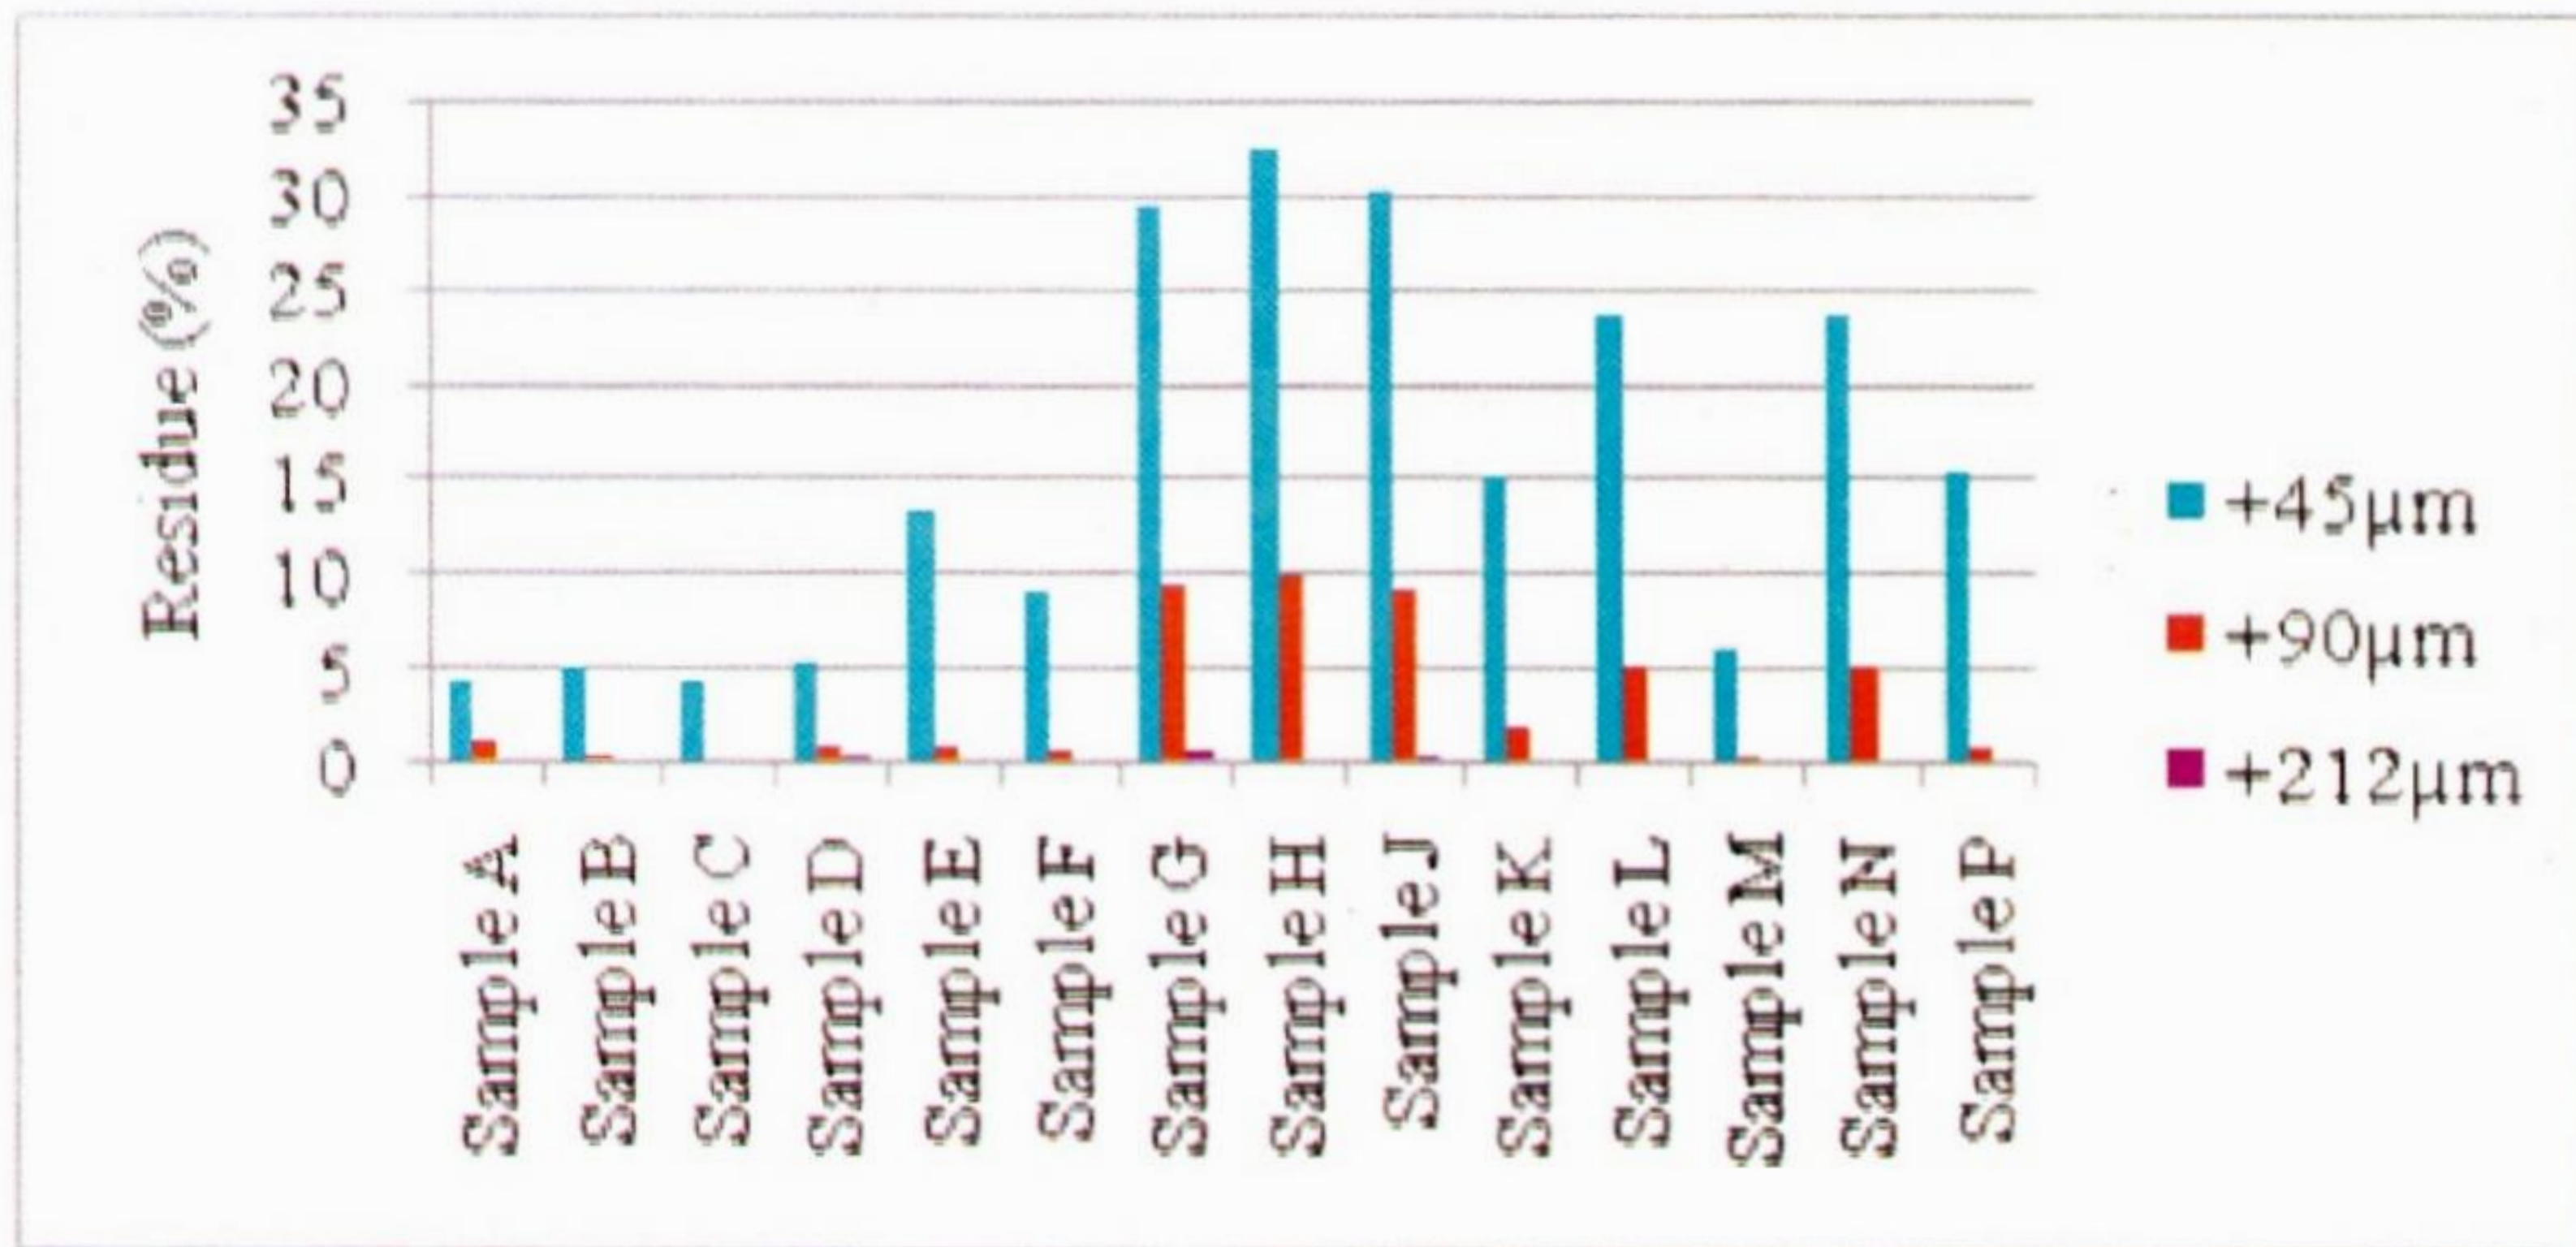
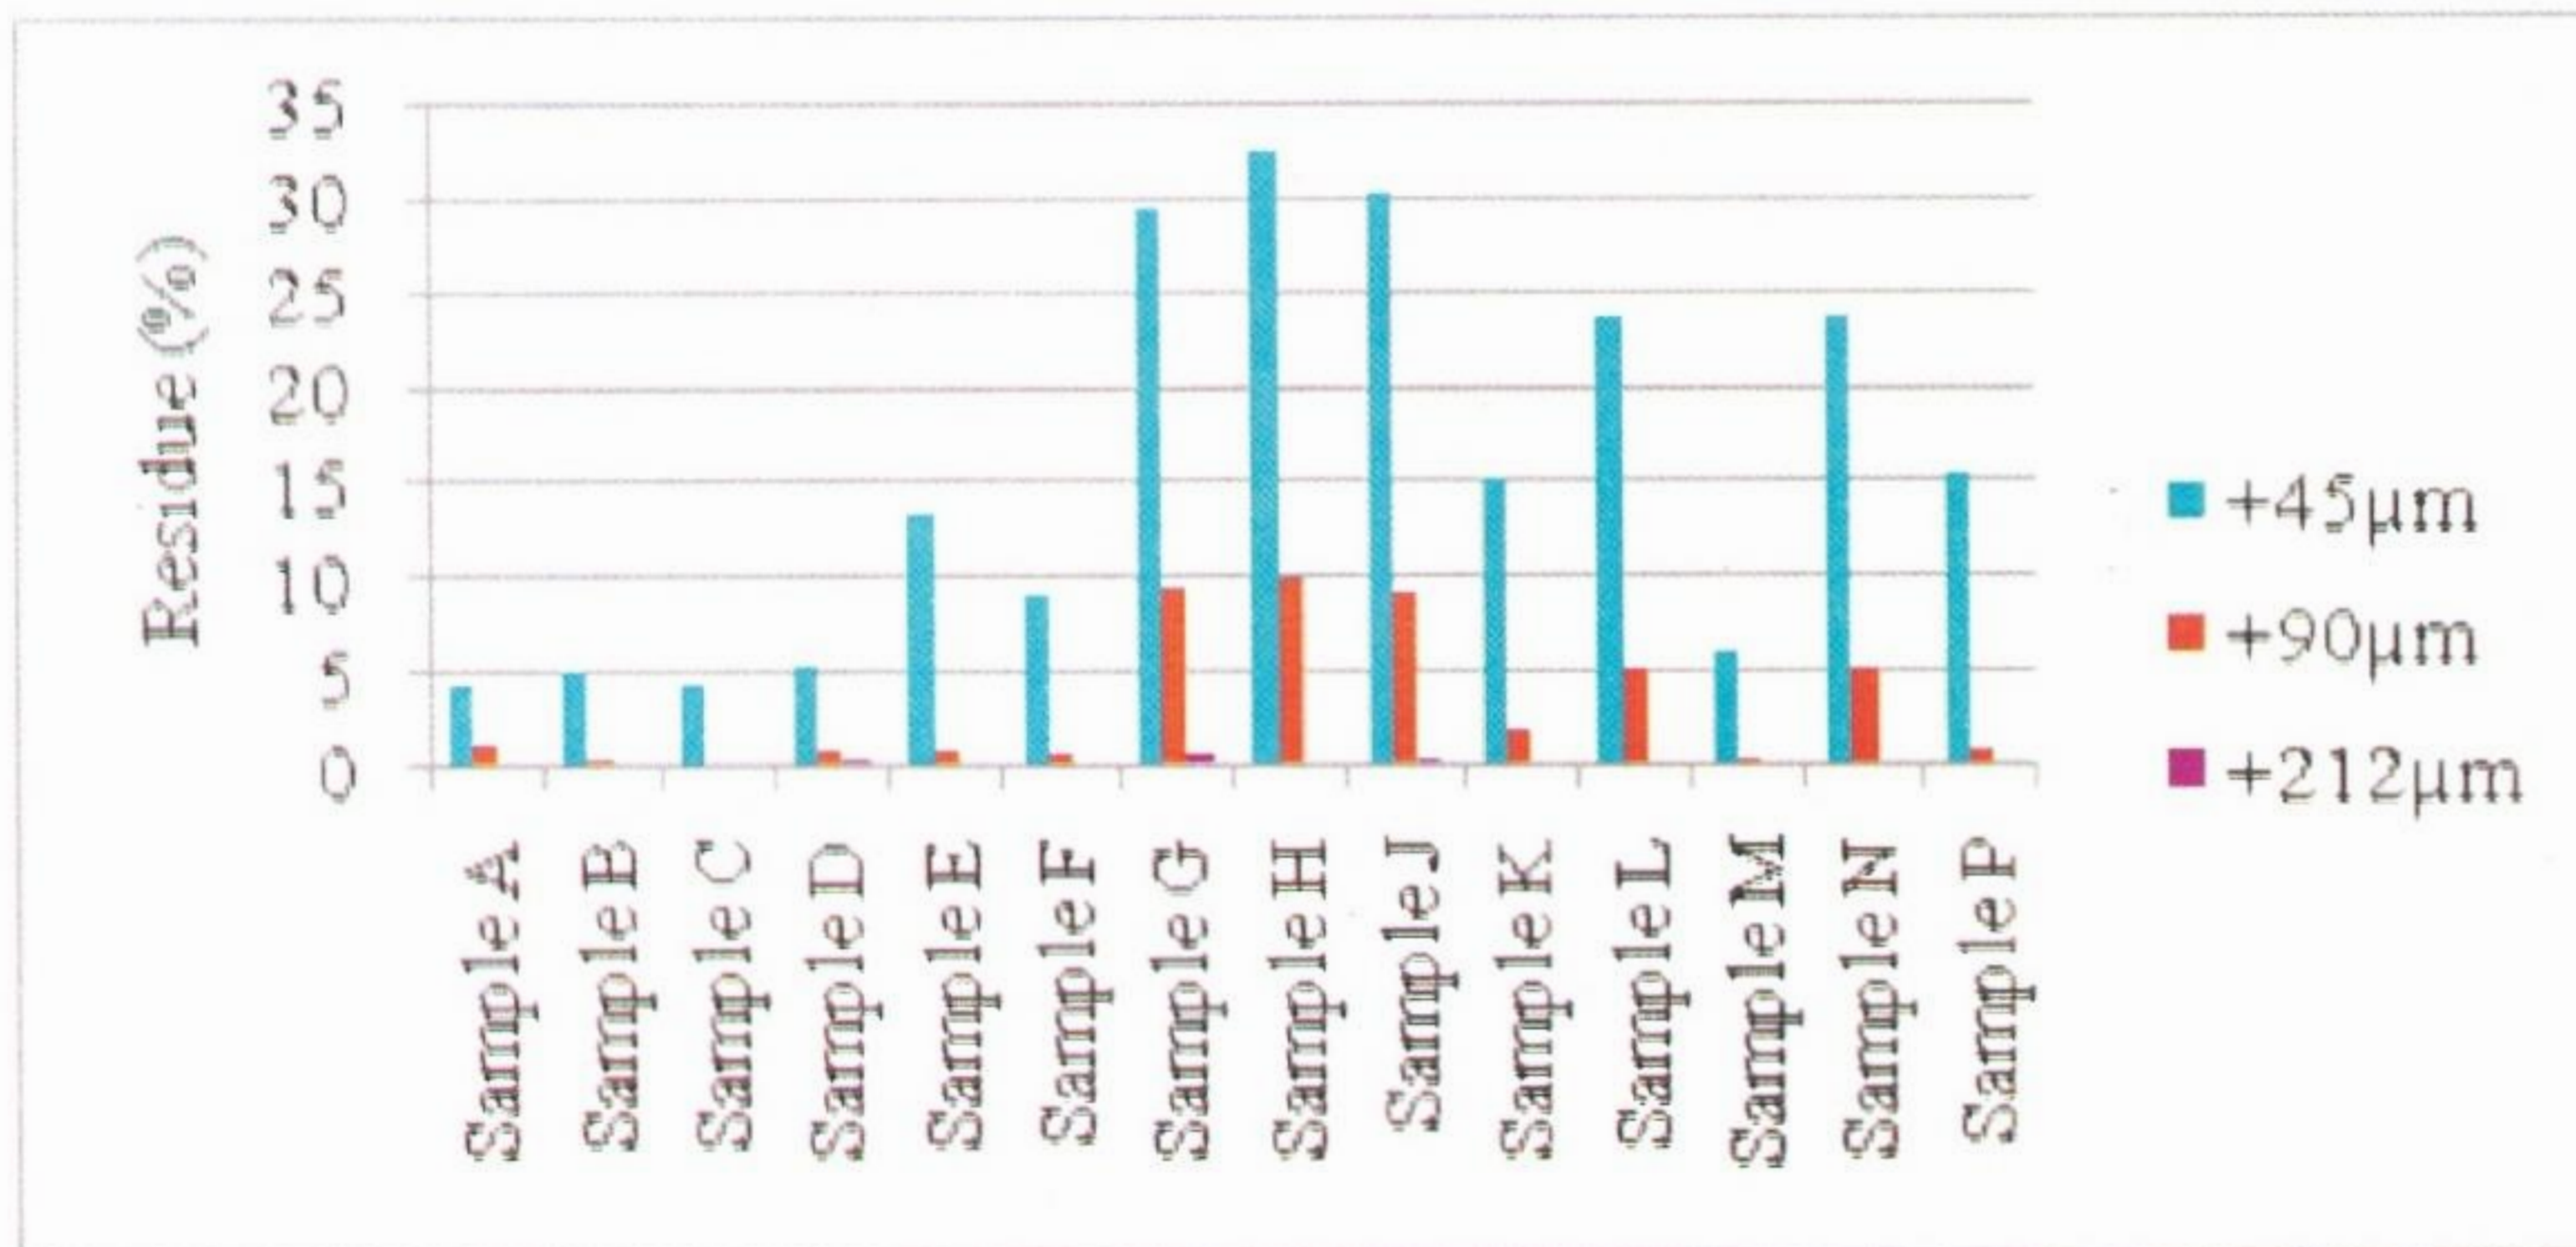
Figure 13: Fineness Test results.

4.2.3 Fineness test: An inverse relationship was observed between the fineness and 28 day cement strengths with a correlation coefficient of high significance (-0.89). Sample H had the highest 45 μ m sieve residue of 32.4%

and the lowest cement strength of 30.40 N/mm² at 28 days while Sample C had the least 45µm residue of 4.4% and the highest cement strength of 60.01 N/mm² at 28 days.

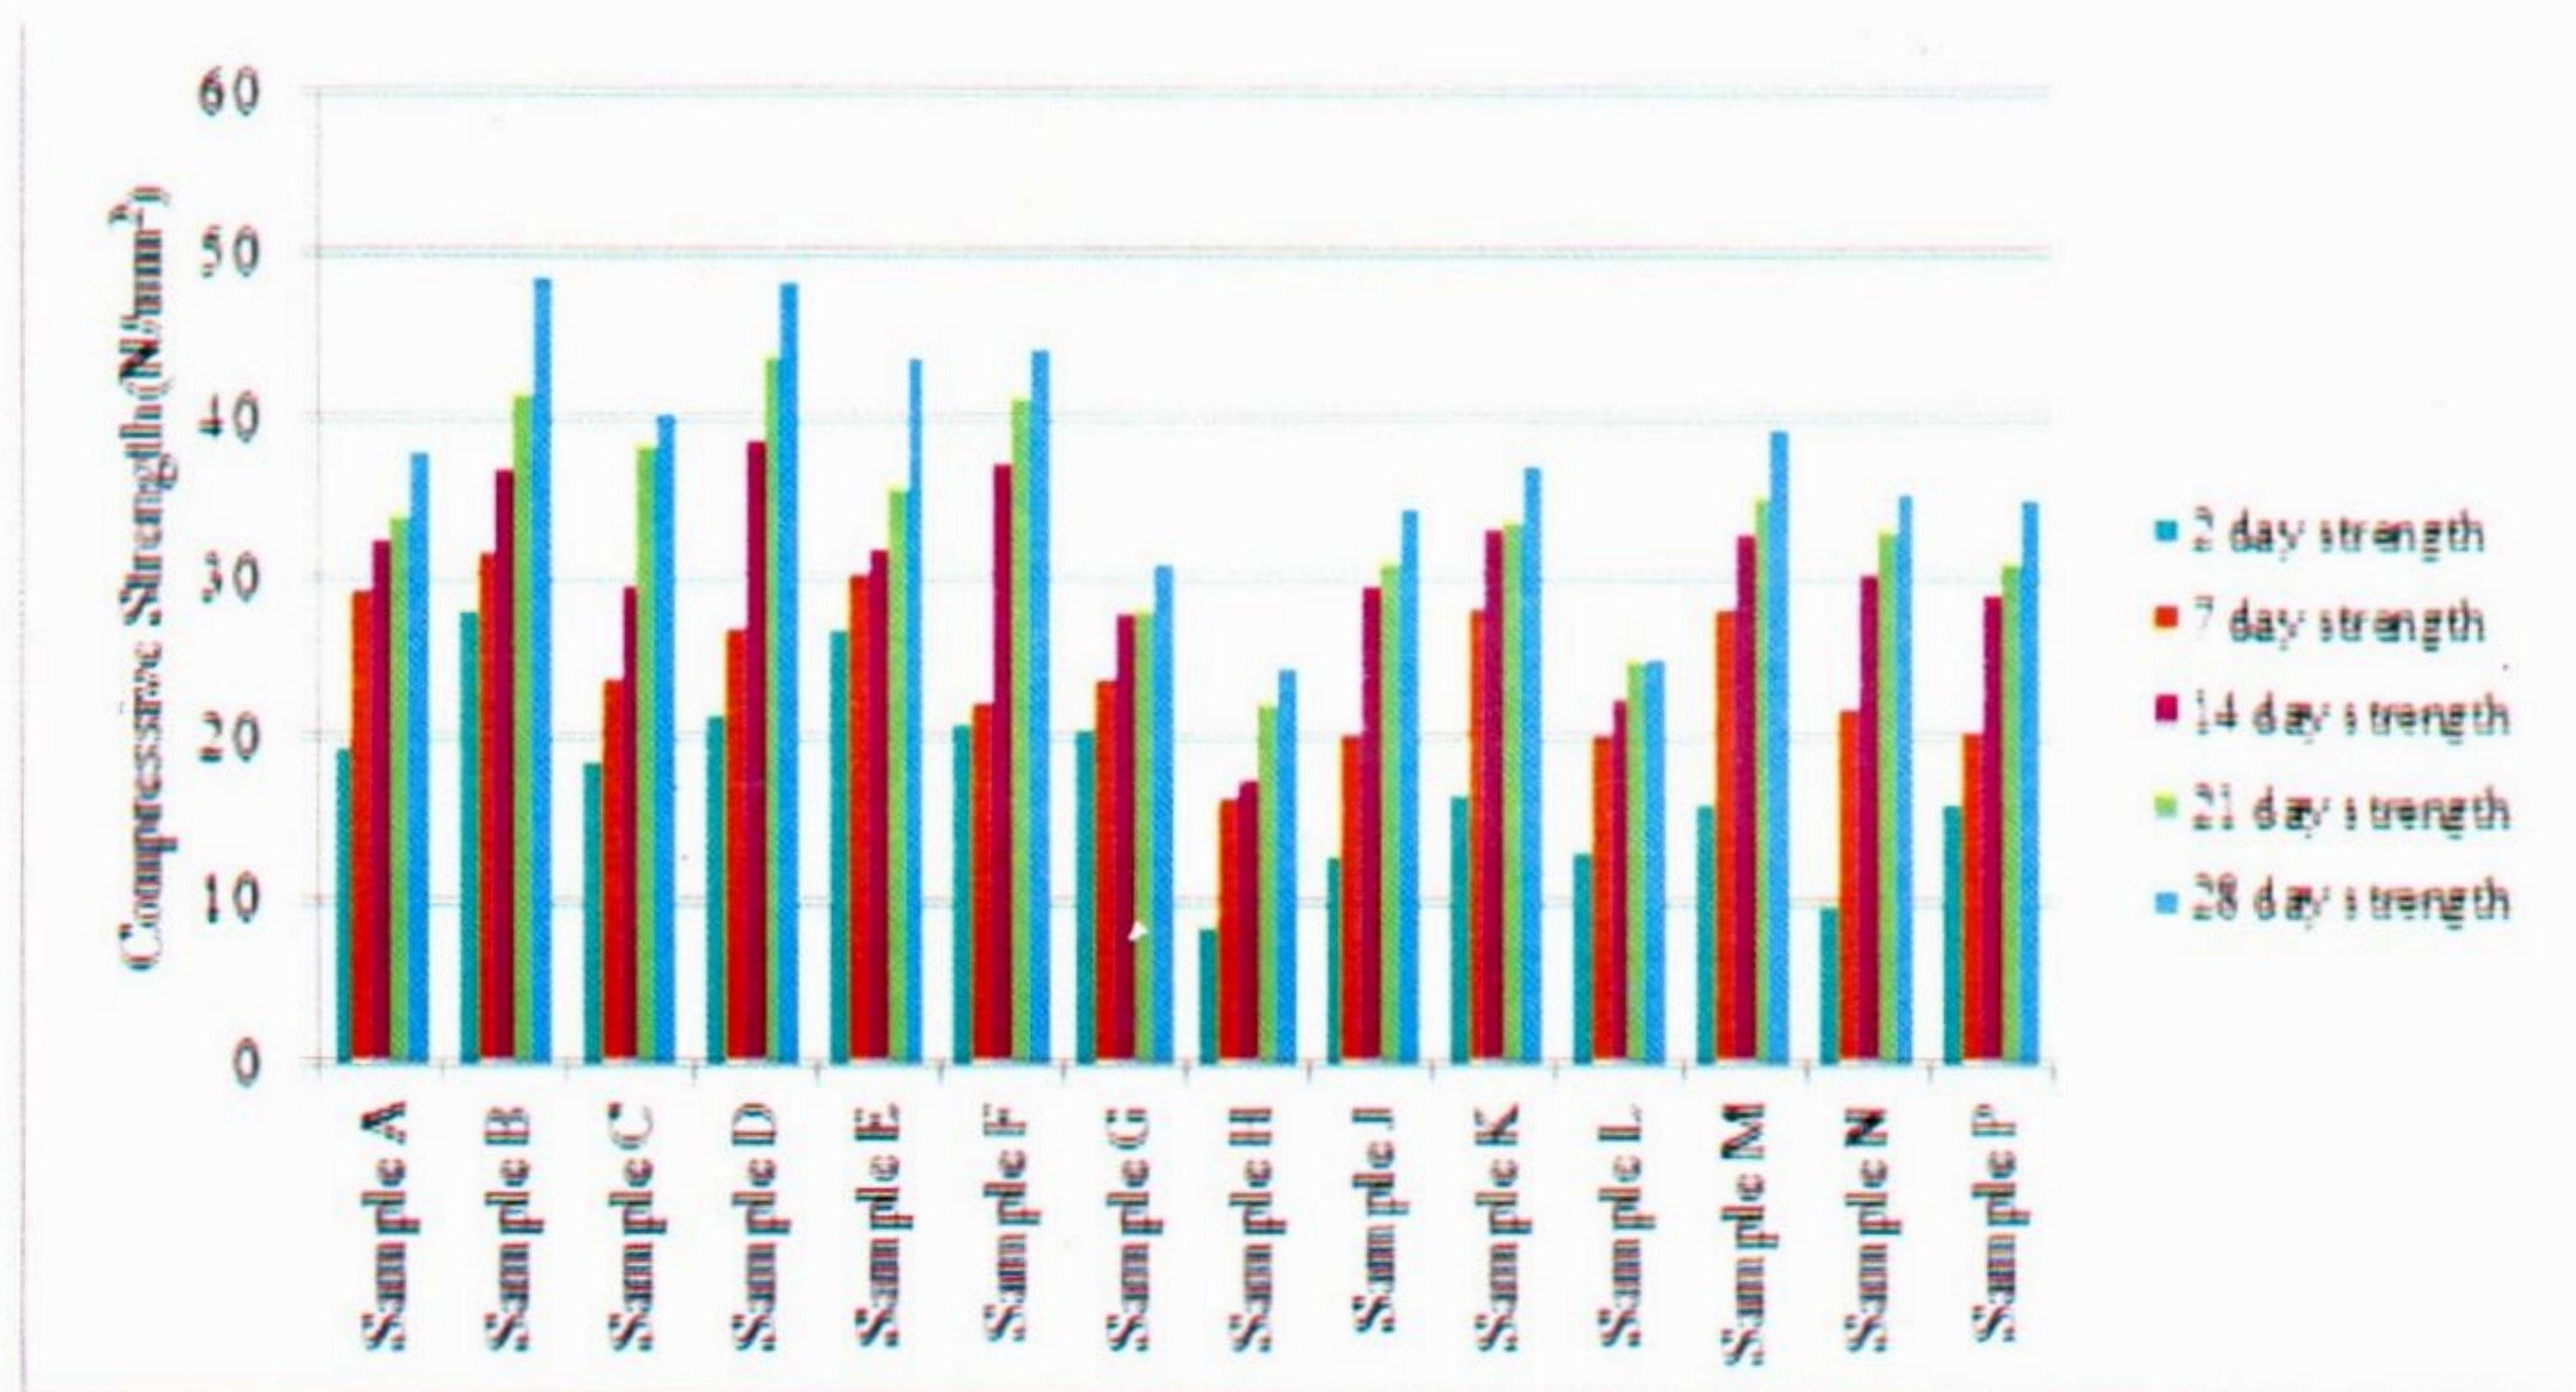
Figure 14: Concrete Compressive Strength.

A correlation between the cement strength and concrete strength of the samples showed a high significance value of 0.91. Sample B had the highest 2 day strength (28.1N/mm²) while Sample H had both the lowest 2 day and 28 day strengths of 8.7 and 24.5N/mm² respectively. Sample D had the highest 28 day strength of 48.6N/mm². Among the cement samples collected, only Sample H did not meet the strength requirements as stated in the SON document for cement production.

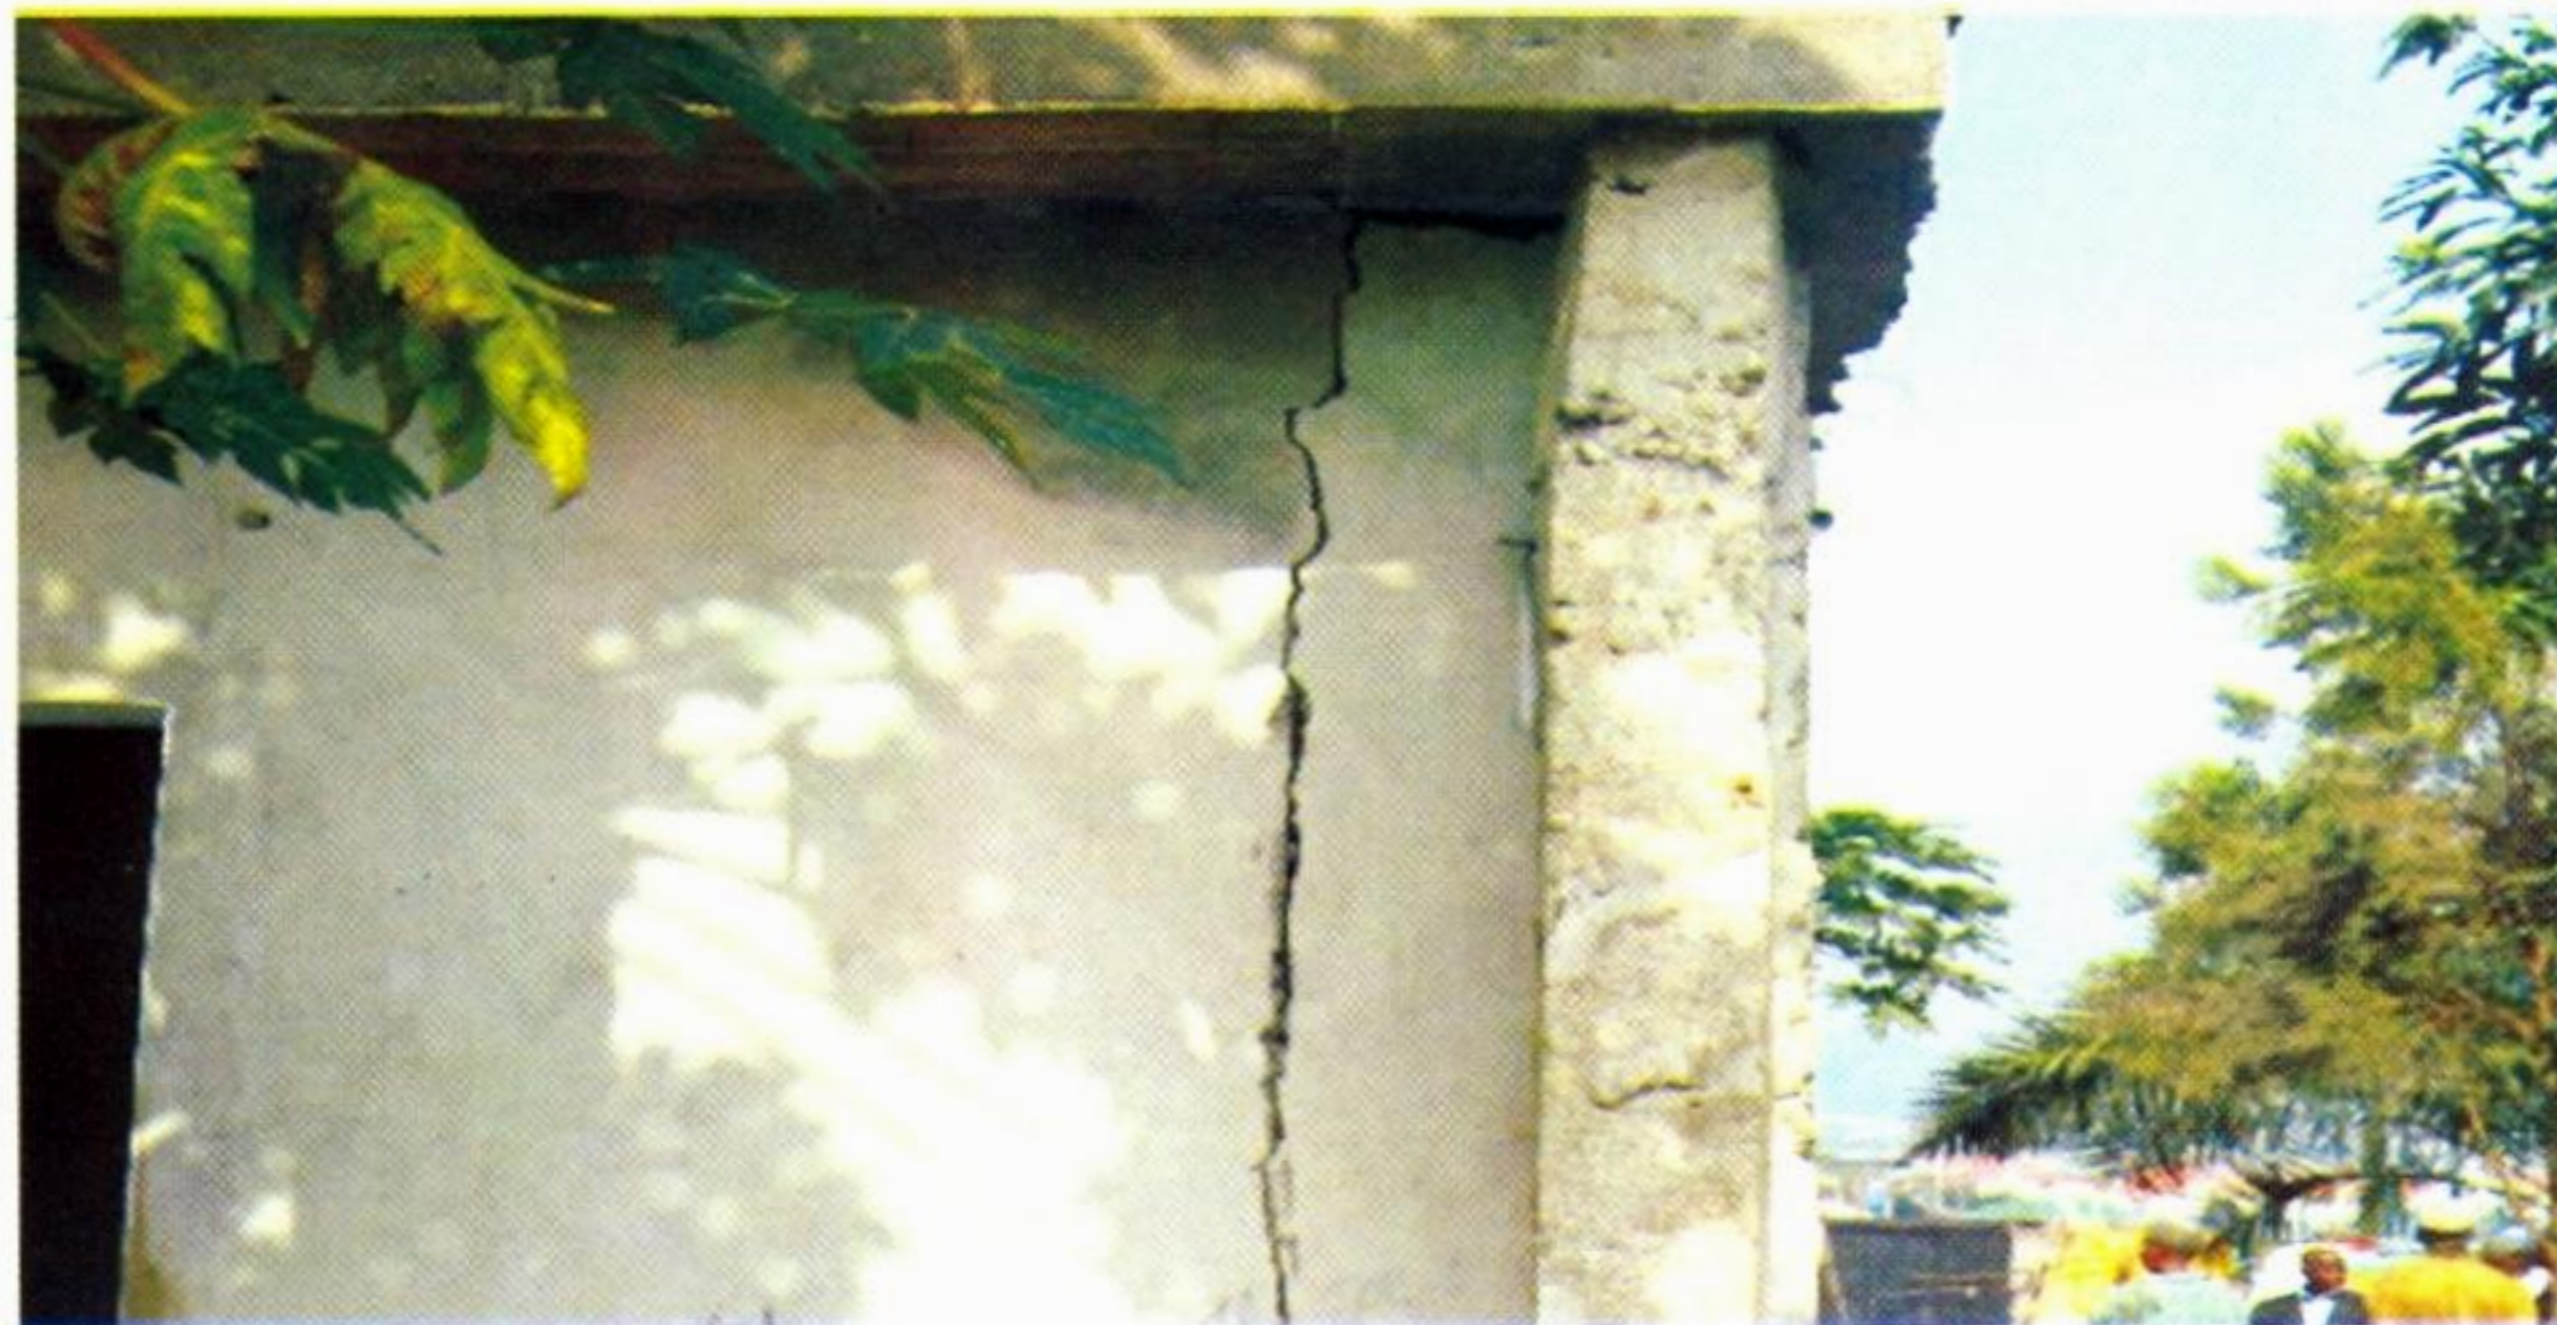
PLATE 12: CRACK ON THE BUILDING DUE TO DIFFERENTIAL SETTLEMENT IN GWARIMPA FHA, ABUJA

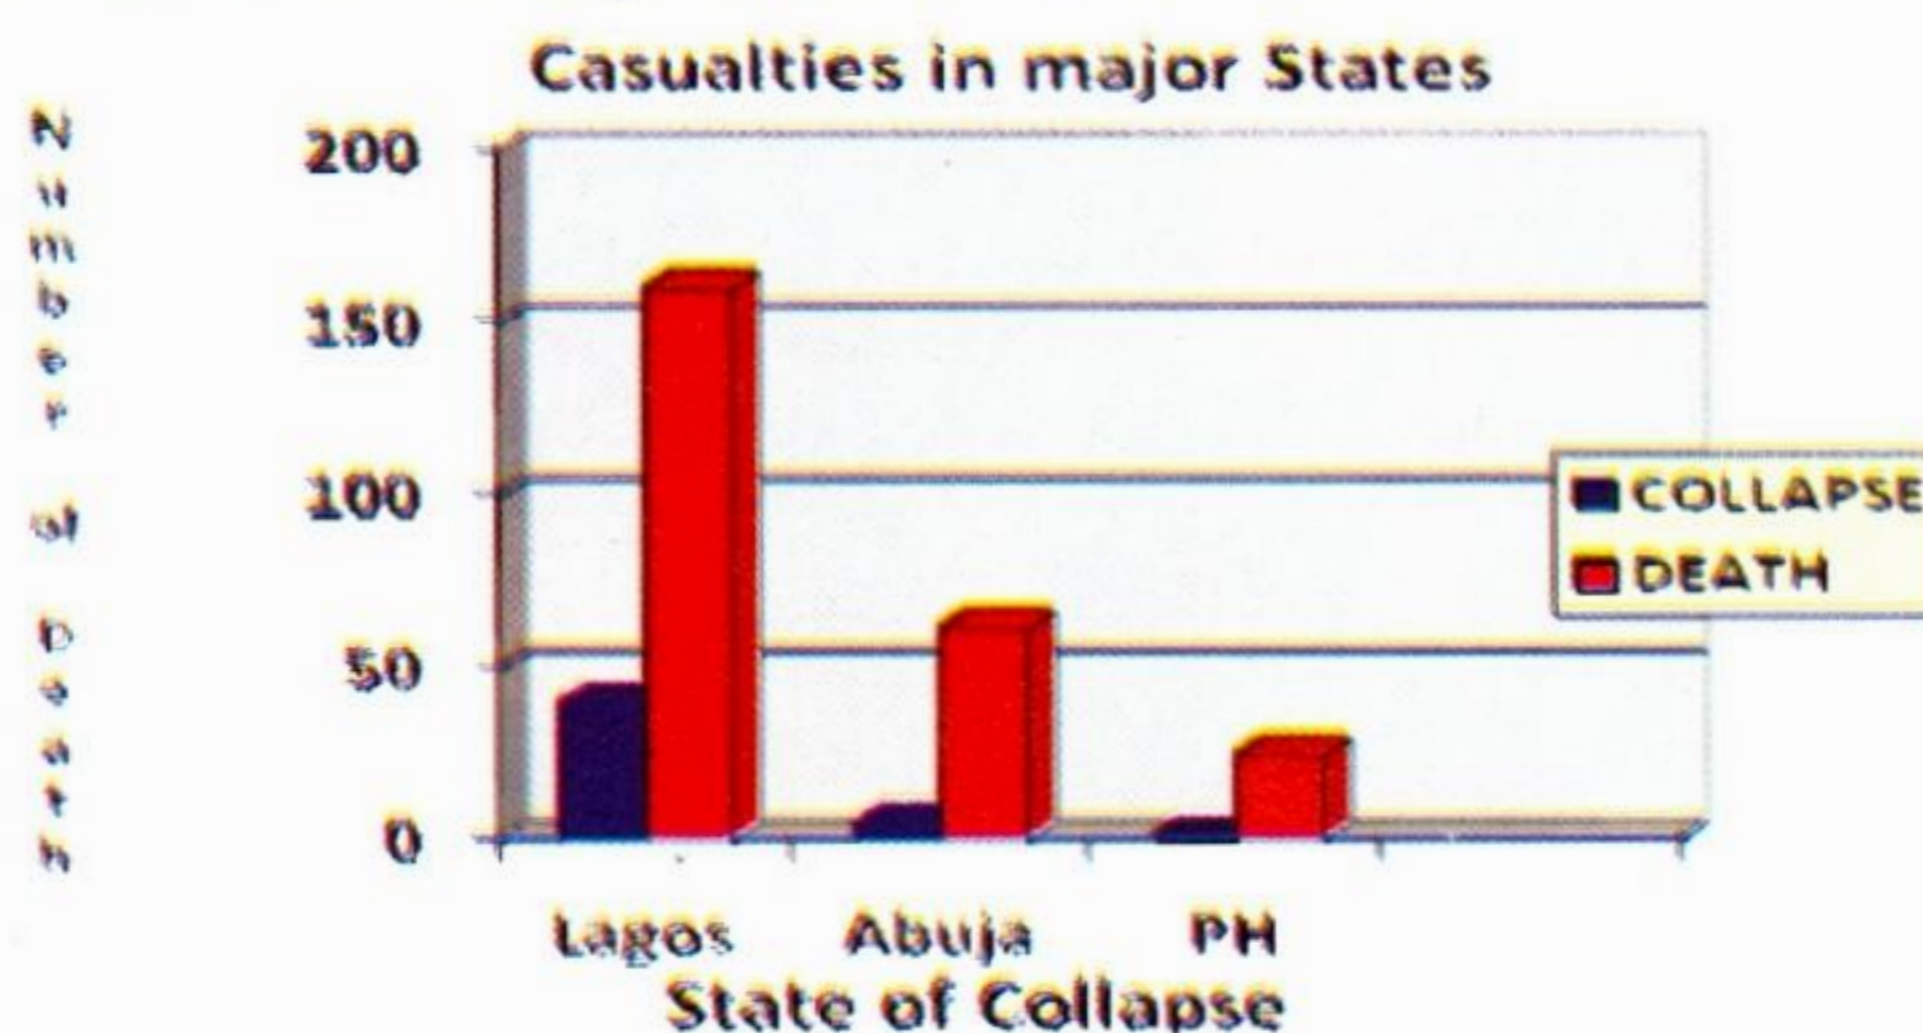
Figure 2: Casualties verified in Lagos, Abuja and Portharcourt
 Source: International Journal of Civil & Environmental Engineering (Dr. Ede A. N, 2010)

Dr. Anthony Nkem Ede of the Department of Civil Engineering, Covenant University, Ota Ogun State, Nigeria in his paper "Building Collapse in Nigeria: The trend of casualties in the last Decade (2000-2010)" said that there have been many papers written on building collapse issues in Nigeria without adequate analysis of death rate involved in the collapses. The result of the analysis of his research is presented here for our perusal.

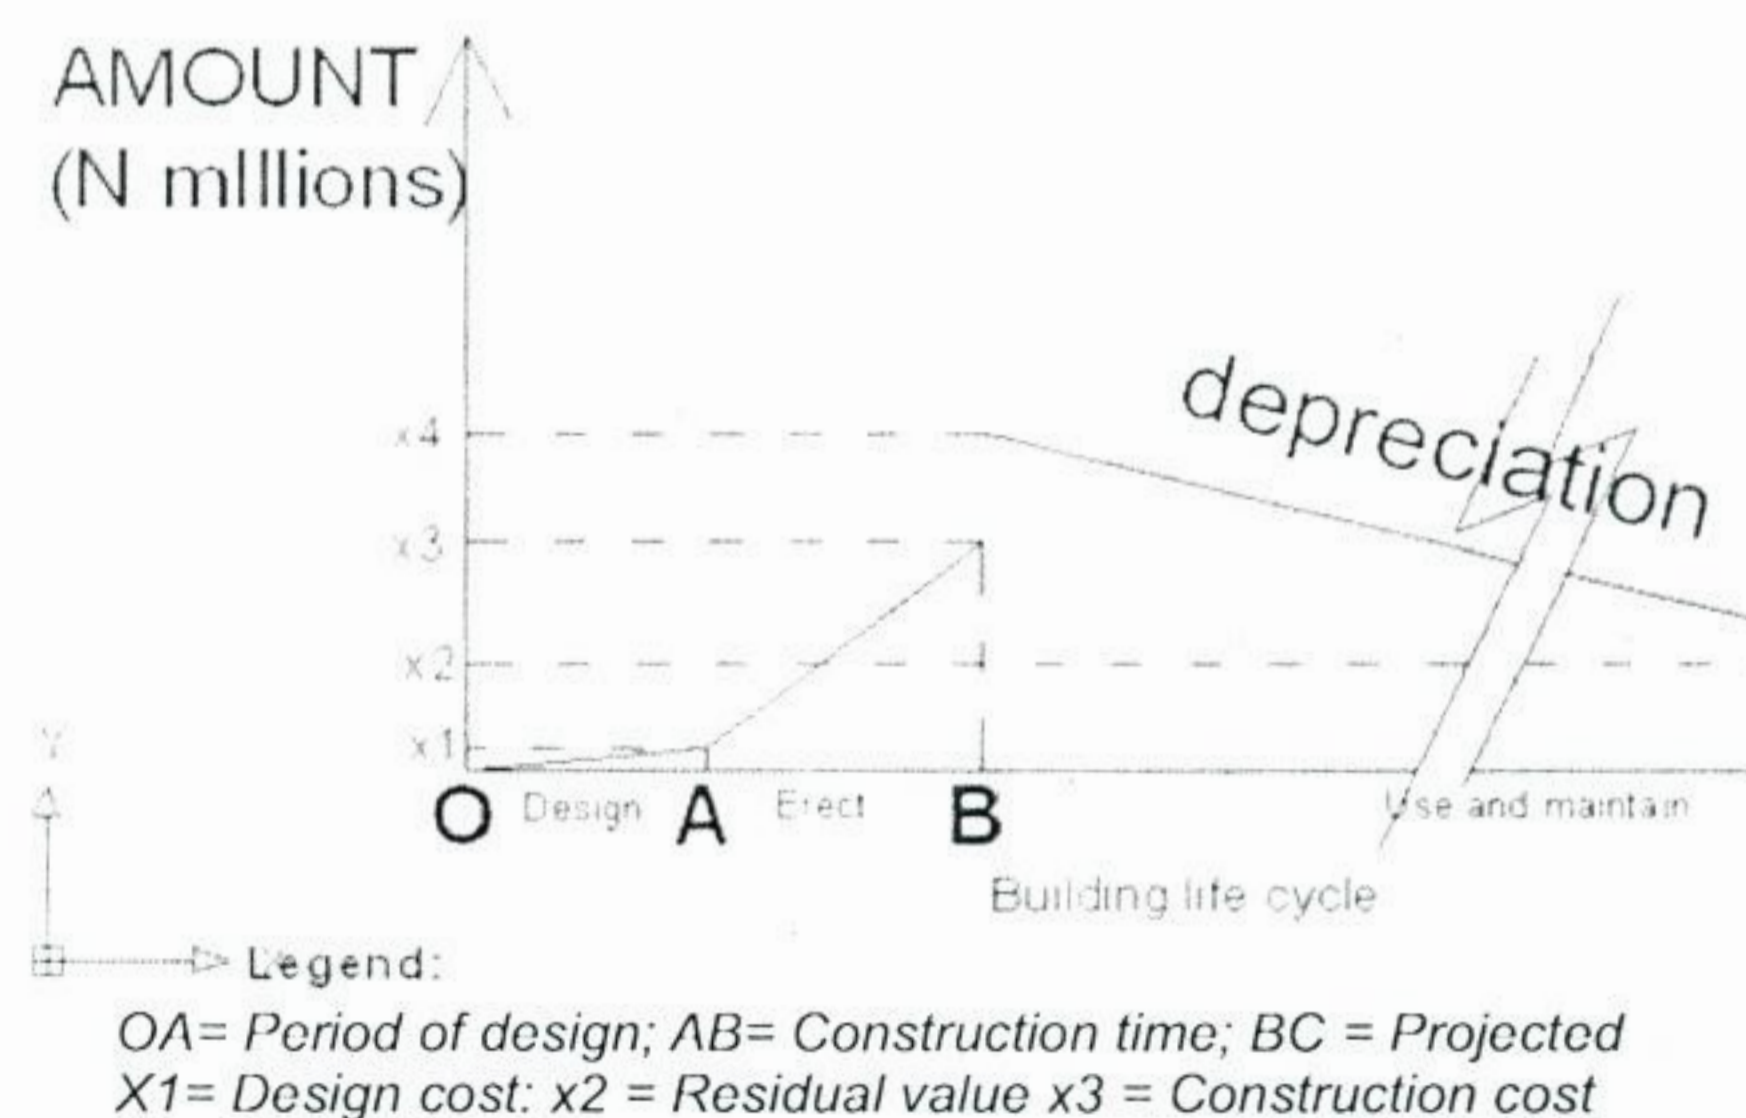
Fig. 4: A Profile of the life cycle of a typical building.

Buildings also have life spans, otherwise known as building life cycle, which commences with the design and terminates at the end of the projected period of validity. Fig. 4A above shows a graphic illustration of the profile of a typical building's life cycle.
